# DRAFT REPORT FOR THE MONITORING OF THE MULLOON CREEK NATURAL SEQUENCE FARMING DEMONSTRATION

Australian Government National Landcare Program Funding # 56319

MULLOON CREEK NATURAL FARMS,  
KING'S HIGHWAY, VIA BUNGENDORE

June 2008

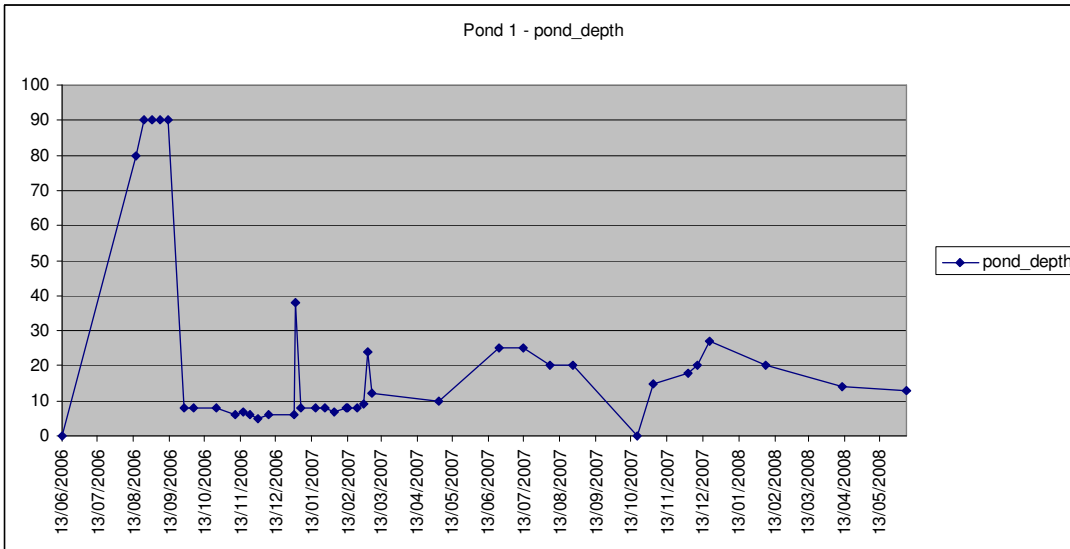
April 2008

Pond 1 is not associated with LW1. LW1 is a de-energising leaky structure approximately 50 metres north from tP1.

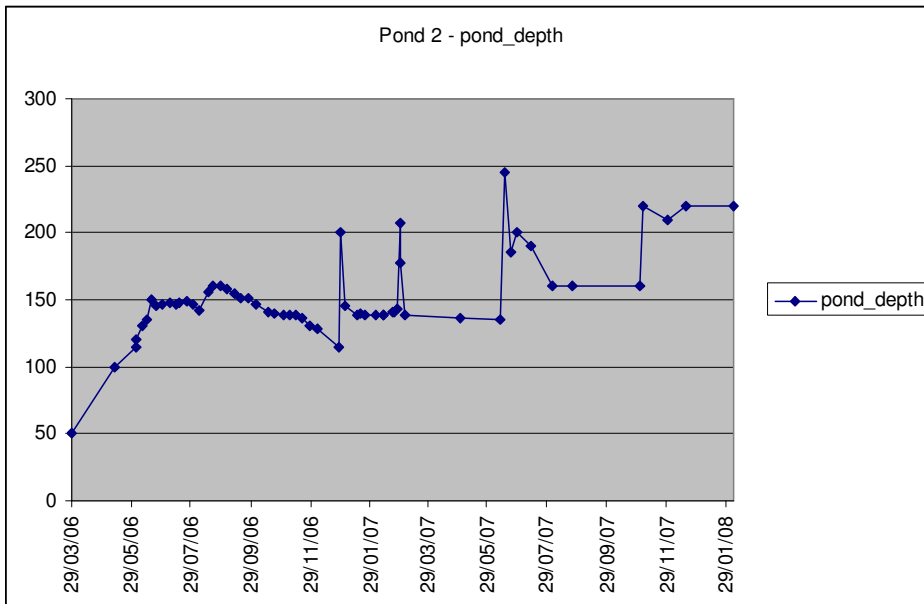
June 2008

Pond depth is currently 220% greater than original depth prior to leaky weir installation. The trend is demonstrating that this is moderately rising.

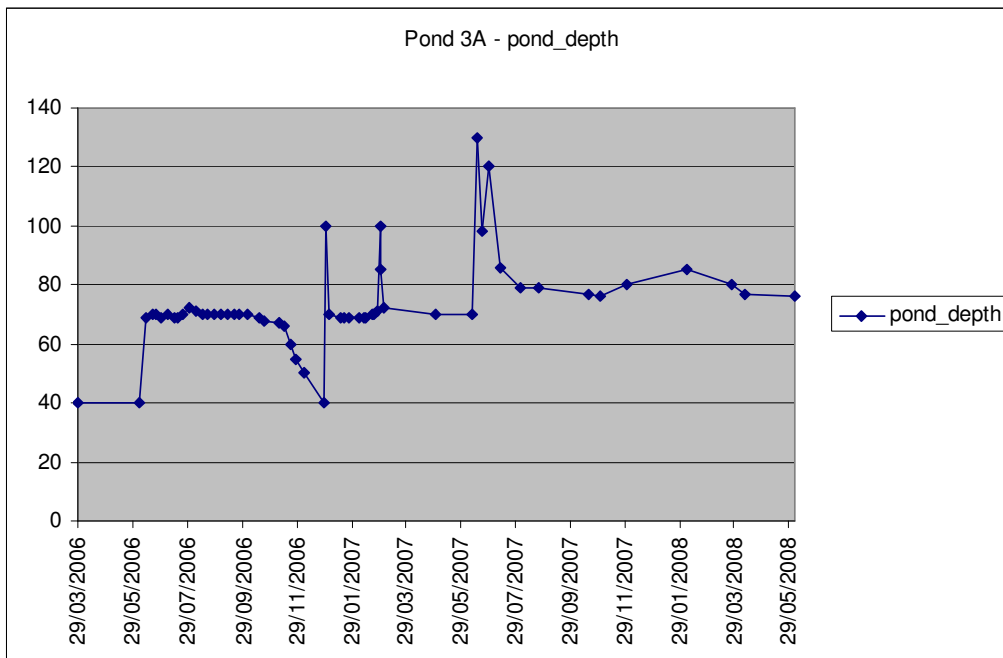
June 2008

Pond depth is currently 190% greater than original depth prior to leaky weir installation. The trend is demonstrating that this is rising.

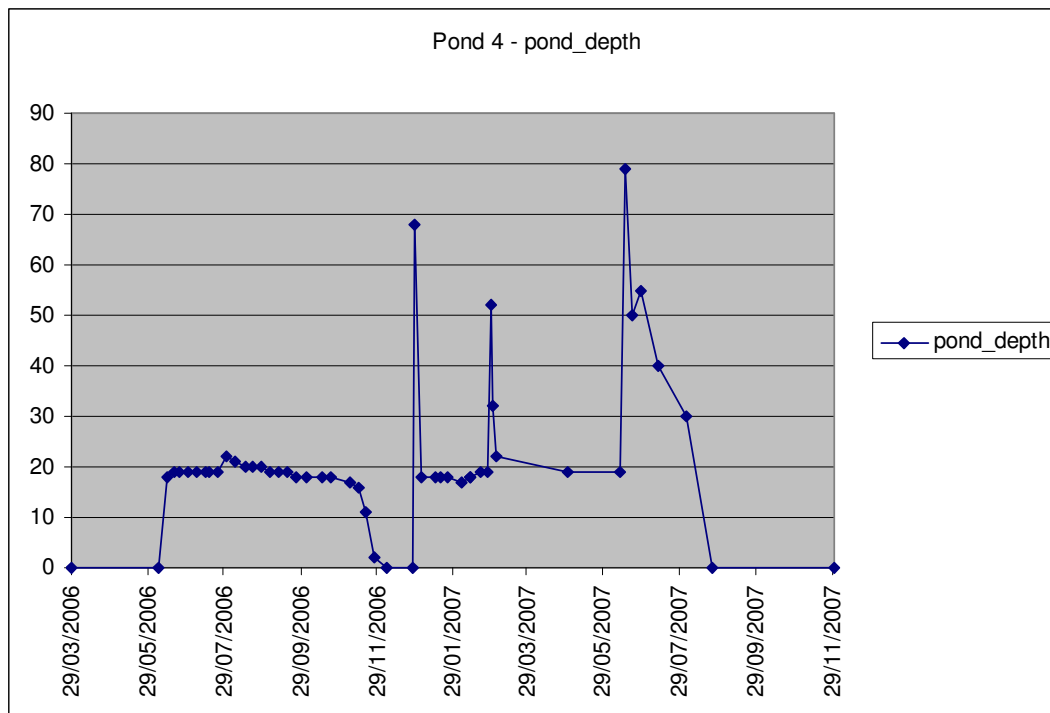
June 2008

Pond depth is was last assessed 30/11/2007 and it was 0 cm depth. This site will have a manual measuring gauge installed in mid June 2008.

Obs: The pond maintains water levels for most of the year.

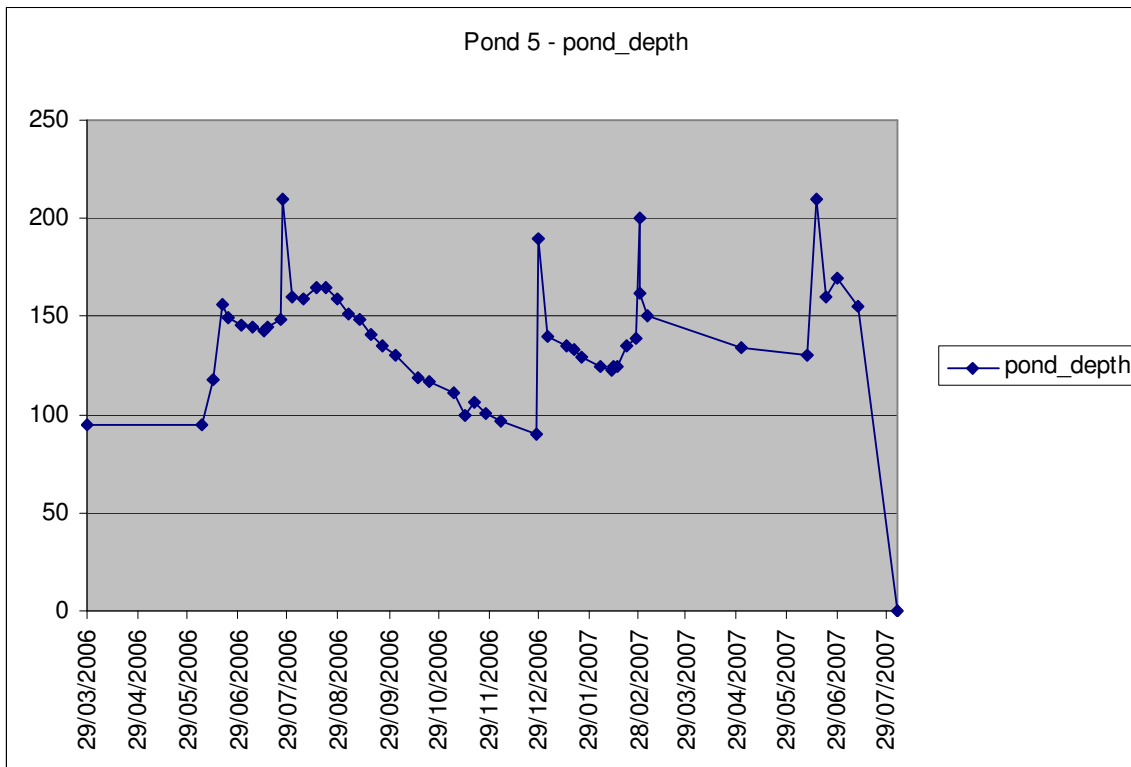
June 2008

Pond depth is currently 163% greater than original depth prior to leaky weir installation. The trend is demonstrating that this is rising slightly.

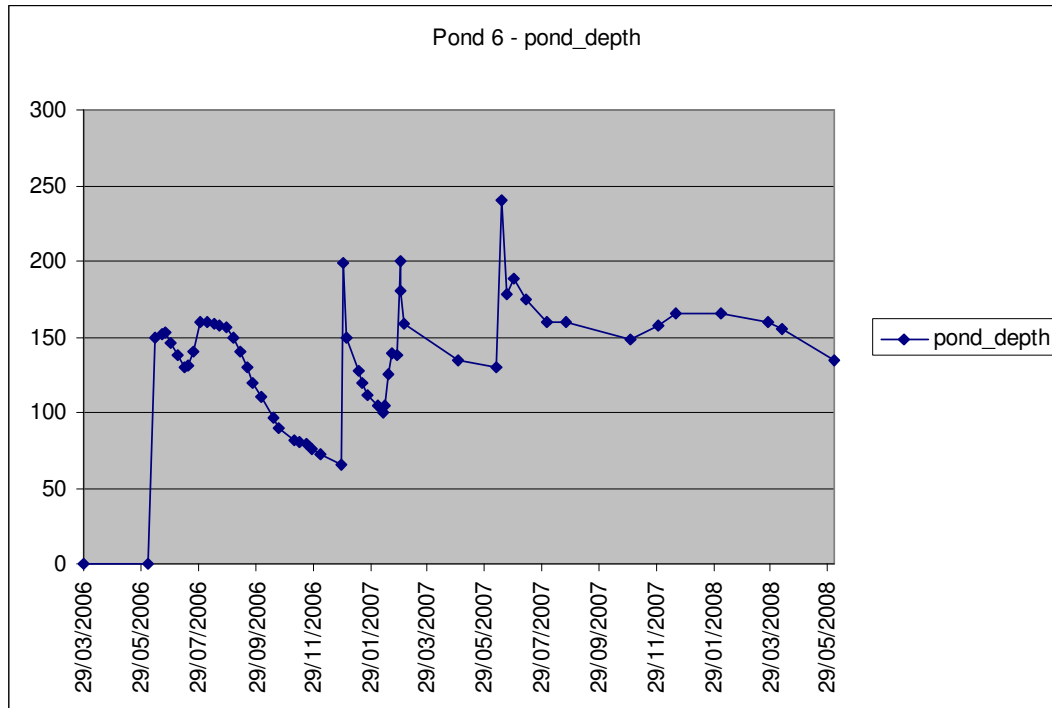
June 2008

Pond depth is currently 135 cm, which was 0 cm prior to leaky weir installation. The trend is demonstrating that this is moderately rising.

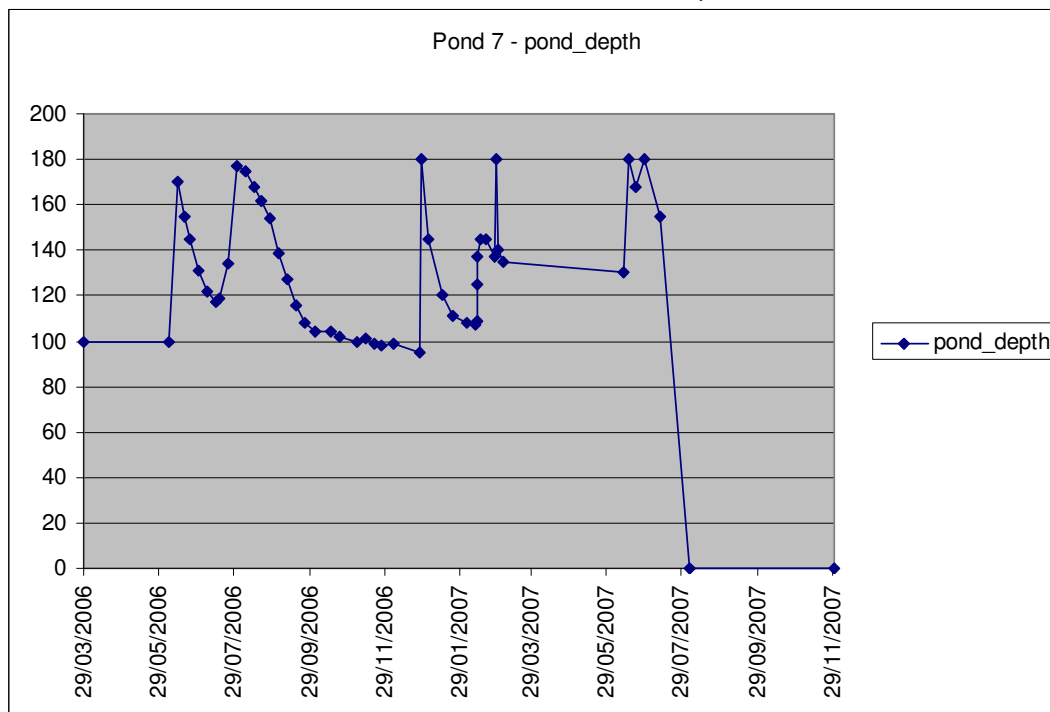
April 2008

Pond depth is currently 155% greater than original depth prior to leaky weir installation. The trend is demonstrating that this is rising slightly.

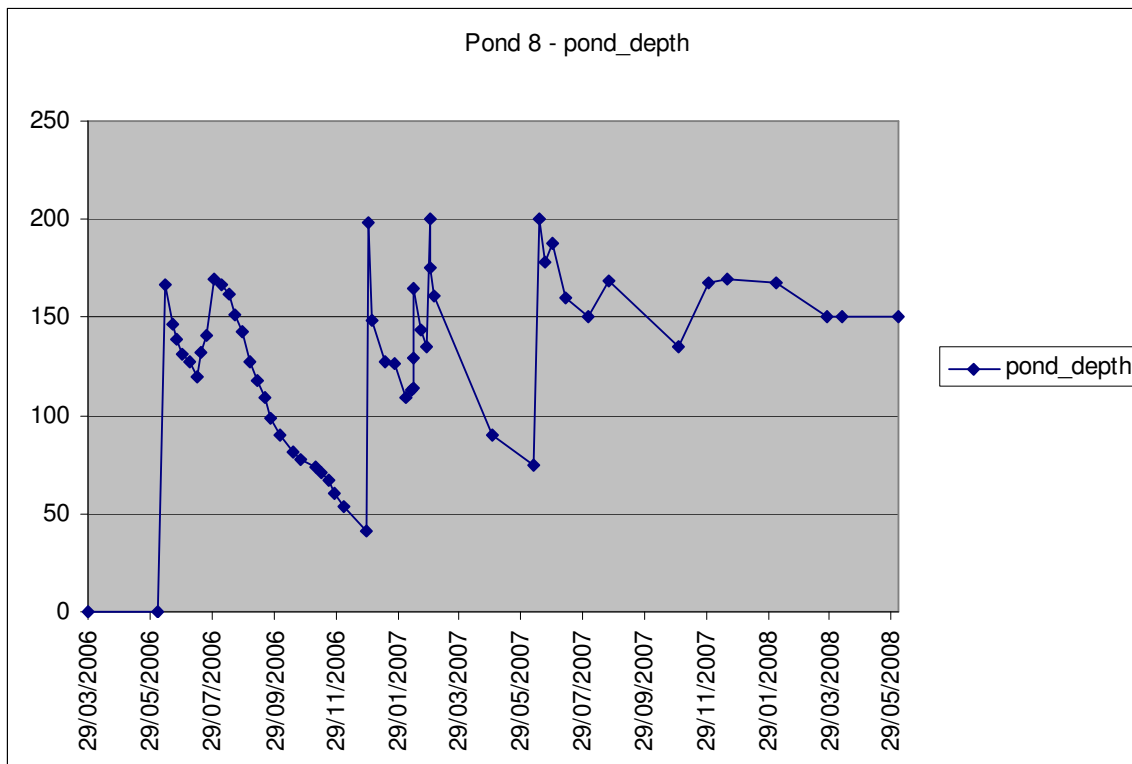
June 2008

Pond depth is currently 150 cm, which was 0 cm prior to leaky weir installation. The trend is demonstrating that this is steadily rising.

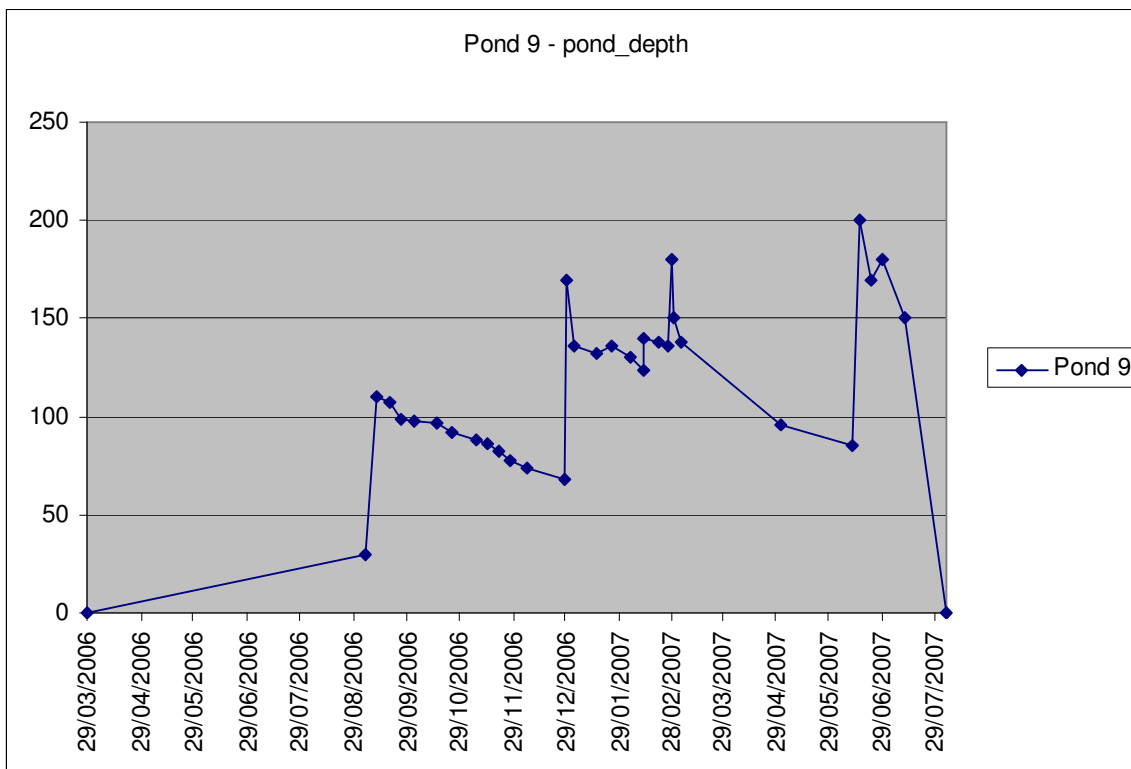
June 2008

**Pond depth:**  
 Pond depth is currently 150 cm, which was 0 cm prior to leaky weir installation. The trend is demonstrating that this is steadily rising.

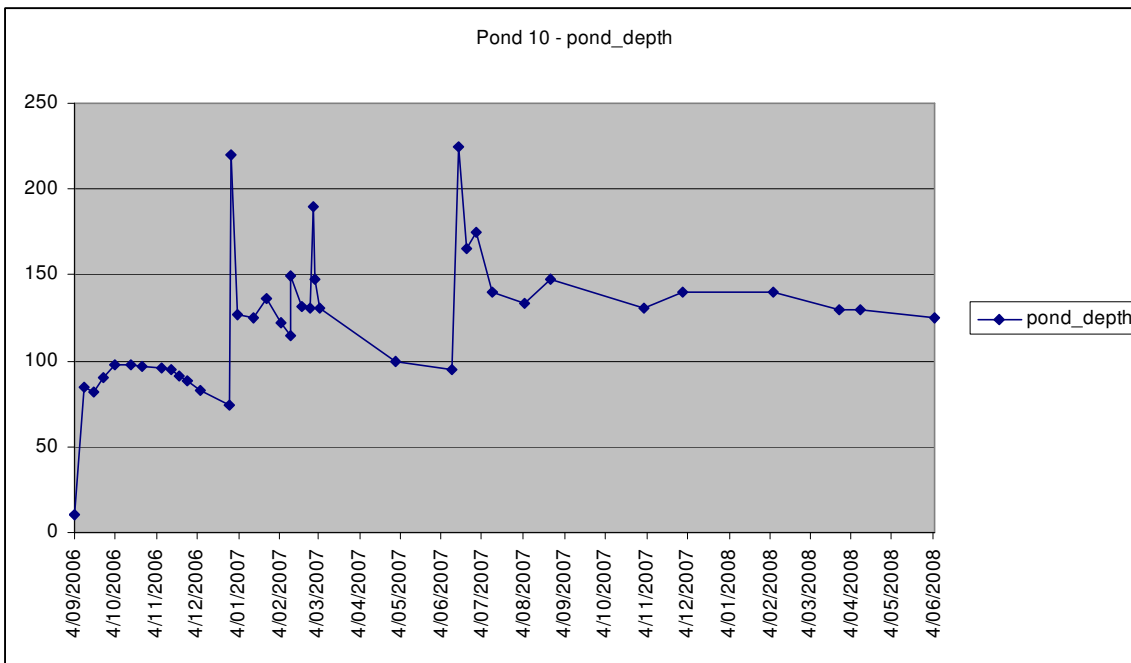
June 2008

Pond depth is currently 1250% greater than original depth prior to leaky weir installation. The trend is demonstrating that this is rising slightly.

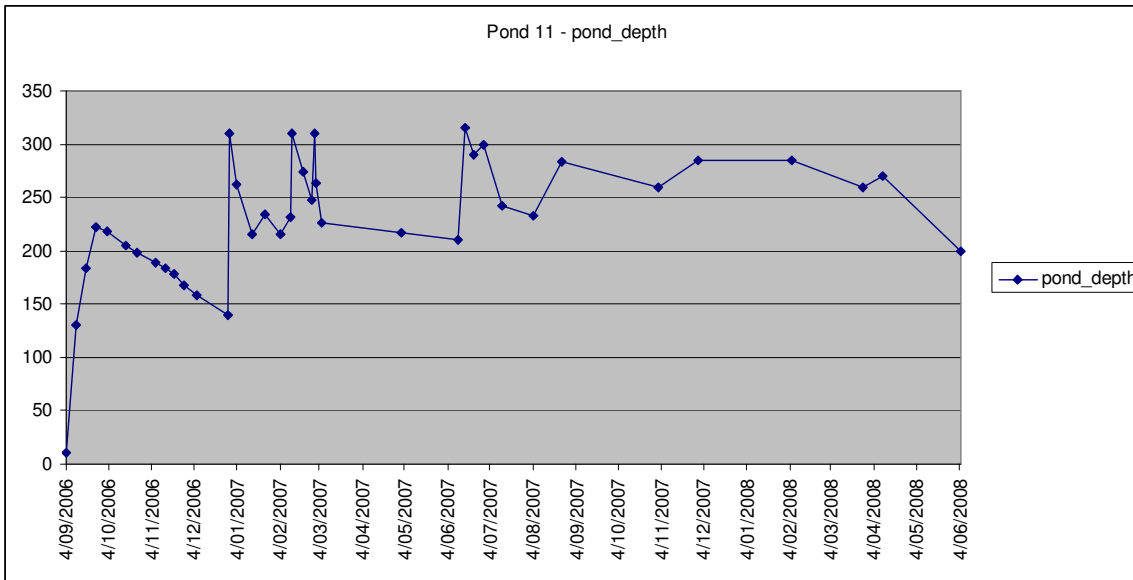
June 2008

Pond depth is currently 2000% greater than original depth prior to leaky weir installation. The trend is demonstrating that this is rising slightly.

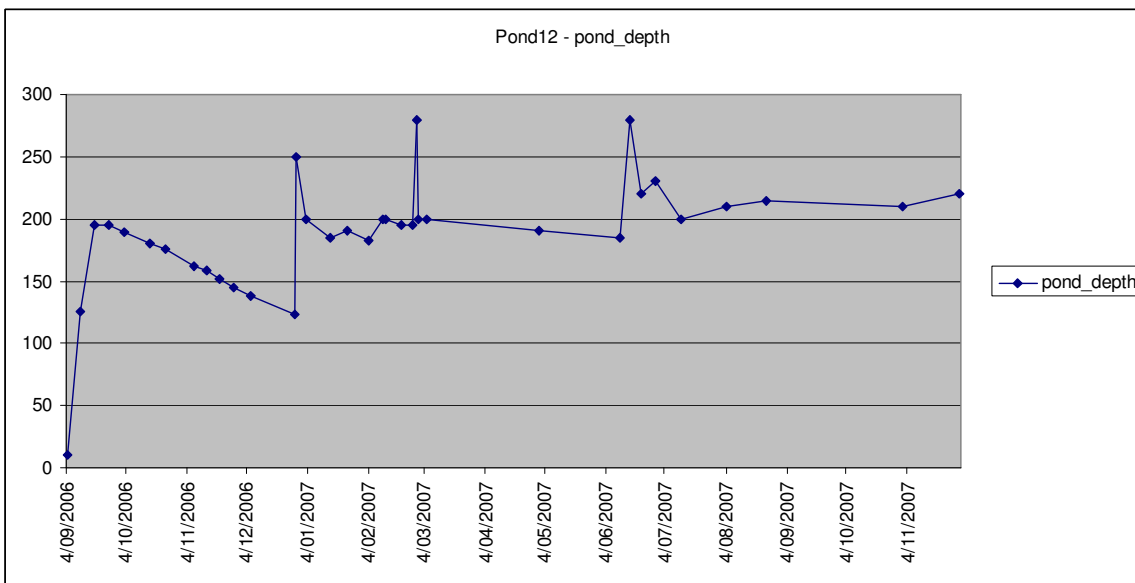
June 2008

**Pond depth:**  
 Pond depth is currently 220 cm, which was 10 cm prior to leaky weir installation (rise by 2200%). The trend is demonstrating that this is steadily rising.

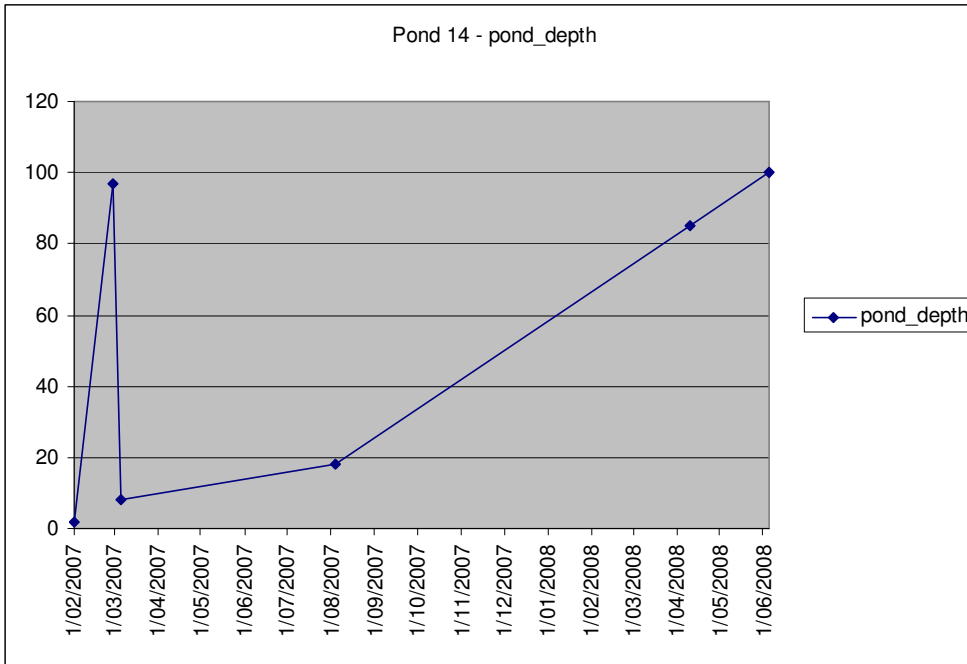
June 2008

Pond depth has increased from 0 to over 100 cm. Observations of the pond have shown that the levels have relatively stable since the installation of the leaky weir structure.

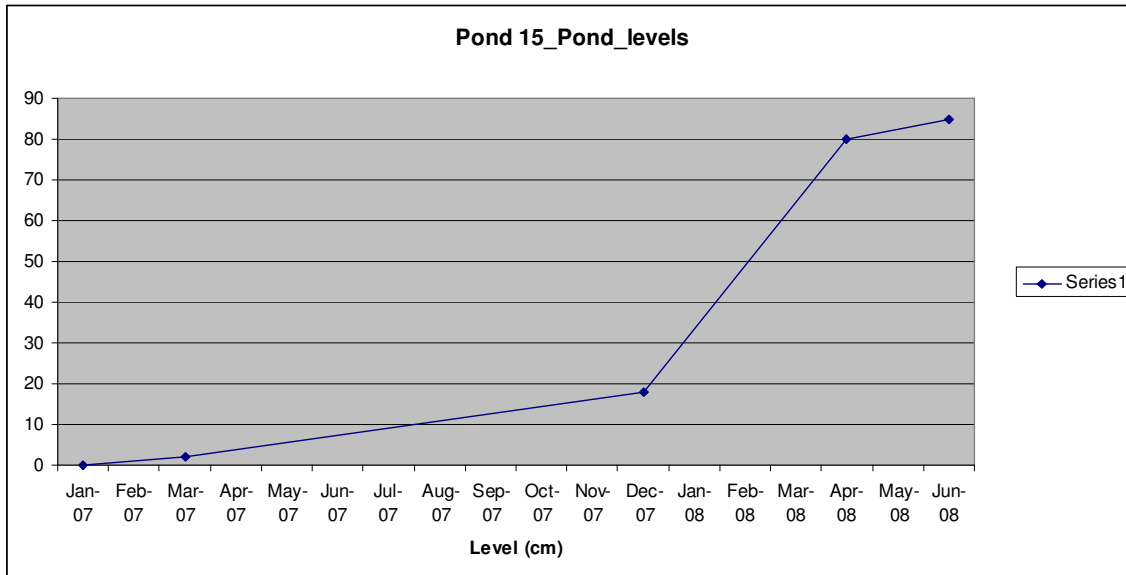
June 2008

Pond depth has increased from 2 to over 85 cm. The trend is demonstrating that this is slightly rising
