REPORT

SOUTHERN RIVERS CATCHMENT MANAGEMENT AUTHORITY

MULLOON CREEK NATURAL SEQUENCE FARMING TRIAL

A Project Summary and Proceedings of a Workshop
(April 18 2011)

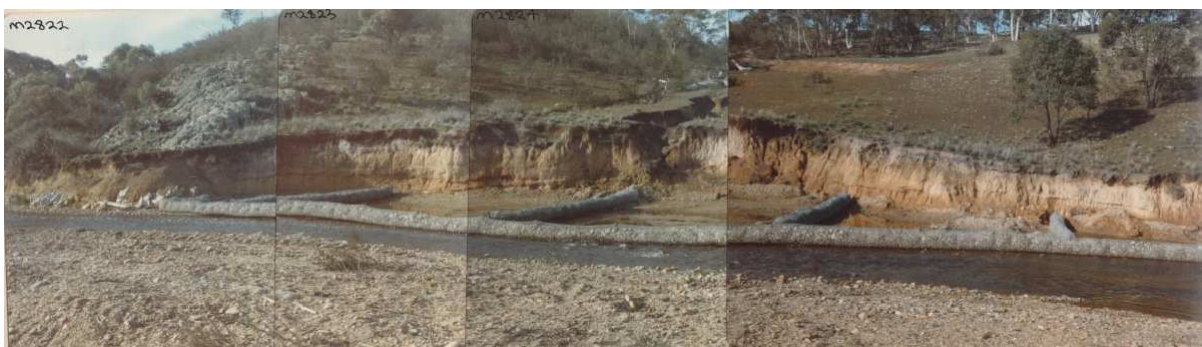
Figure 1.1. Rock sausages placed along Mulloon Creek in 1980 at the site where Weatherstation crossing is now located (see Table 2 and Figure 3 for location).

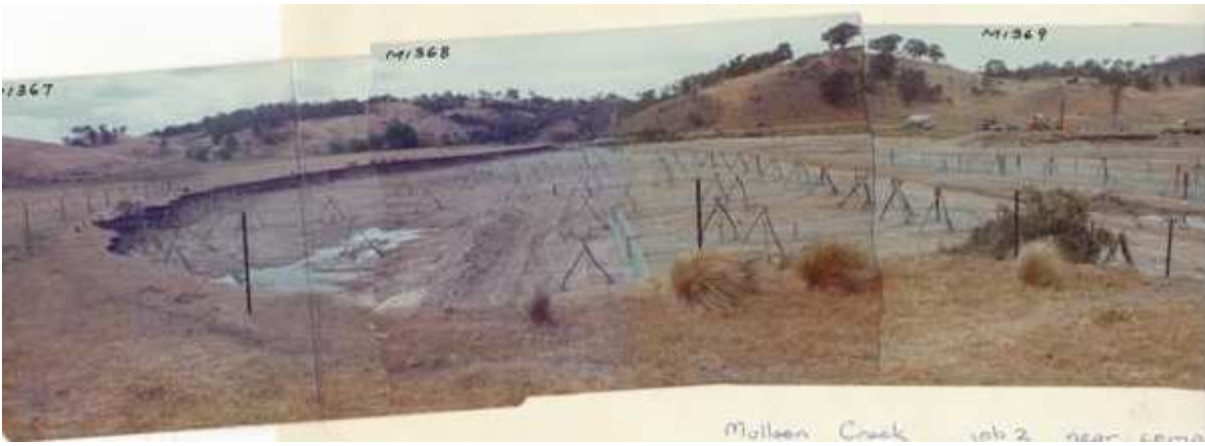
Figure 1.2. Willow propagation via placement of tripods of willow canes at the site where Willows Crossing now occurs (see Table 1.2 and Figure 1.3 for location)

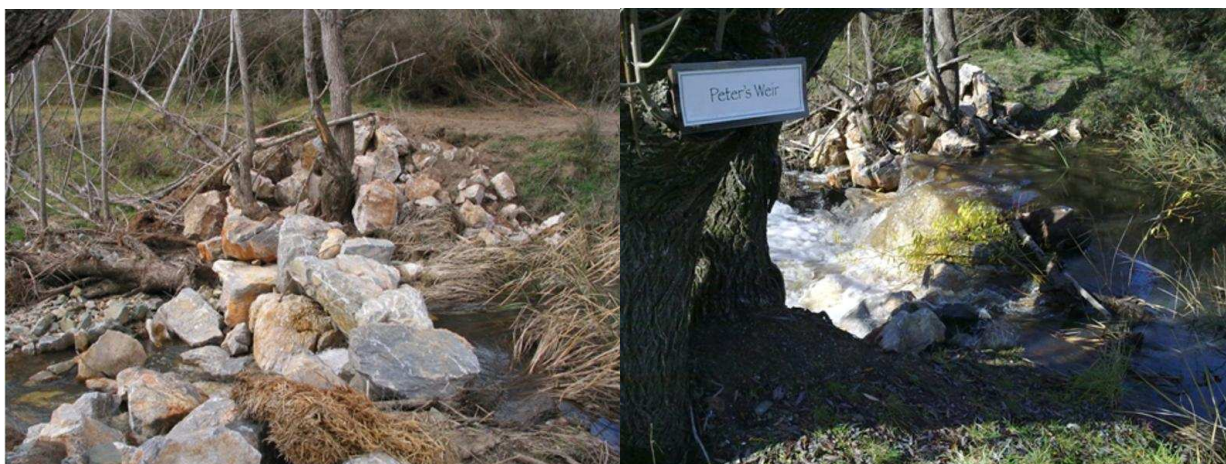
Figure 1.4. Peters Weir (LW2), August 14, 2007 on the left and April 4, 2011 on the right.

An example of this type of structure is 'Peters Weir (Figure 1.4). This leaky rock weir at Peter's Pond is designed to retard flows and retain a body of water that raises the level of groundwater in the adjacent floodplain.

- The height of this leaky weir is 1.2m;
- The structure consists of rocks between 0.25 m and 1 m diameter;
- The willow tree on the Western bank plays a critical role in stabilising the structure;
- A willow branch lodged in the centre of the structure has become established and is assisting to anchor the rock in place;
- This weir was repaired in 2008 by adding more limestone rocks.
- Vegetation established in the pond upstream of this structure is playing a role in enhancing its' stability.

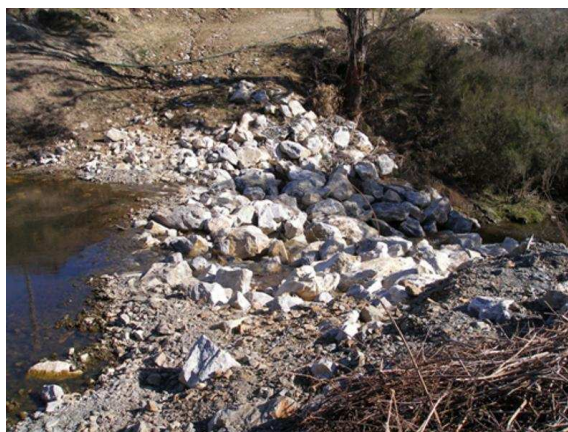
Figure 1.5. Pump-station Weir (LW14) in 2007.

The other large rock weir at Mulloon Creek is 'Pump Station Weir' (Figure 1.5). Large rocks were also incorporated into many of the other structures.

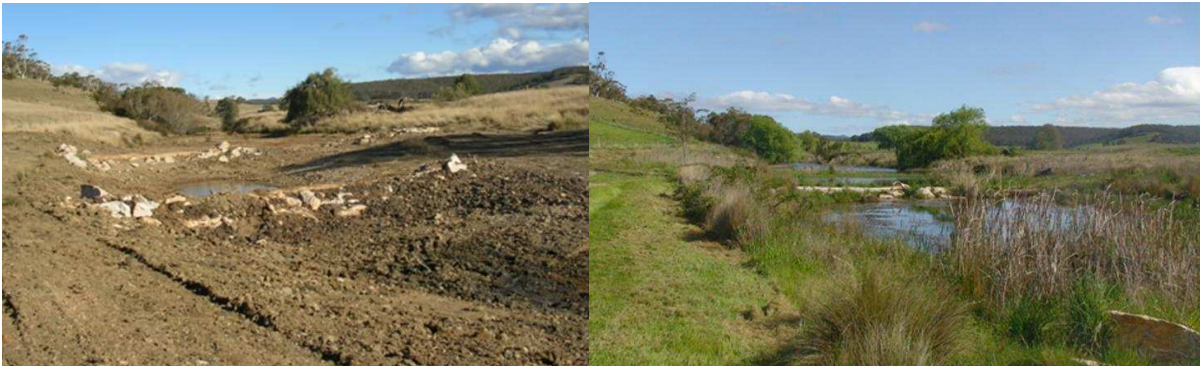
Figure 1.6. Triple Ponds Crossing (LW8) under construction 2006 on the left and Oct 2009 on the right.

Examples of log sills include: "Willows Crossing" (LW5), "Williams Wallow" (LW7), Poplars Crossing (LW12) and Triple Ponds Crossing (LW8) (See Figure 1.6 and 1.7).

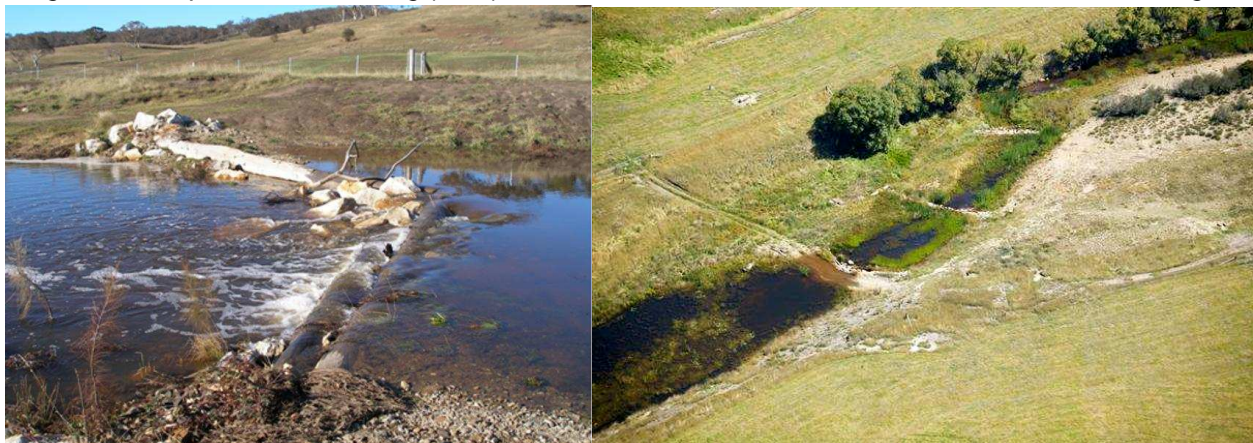
Figure 1.7. Upstream structure of Triple Ponds Crossing (LW8a) 2007 and a view of the three structures (2008).

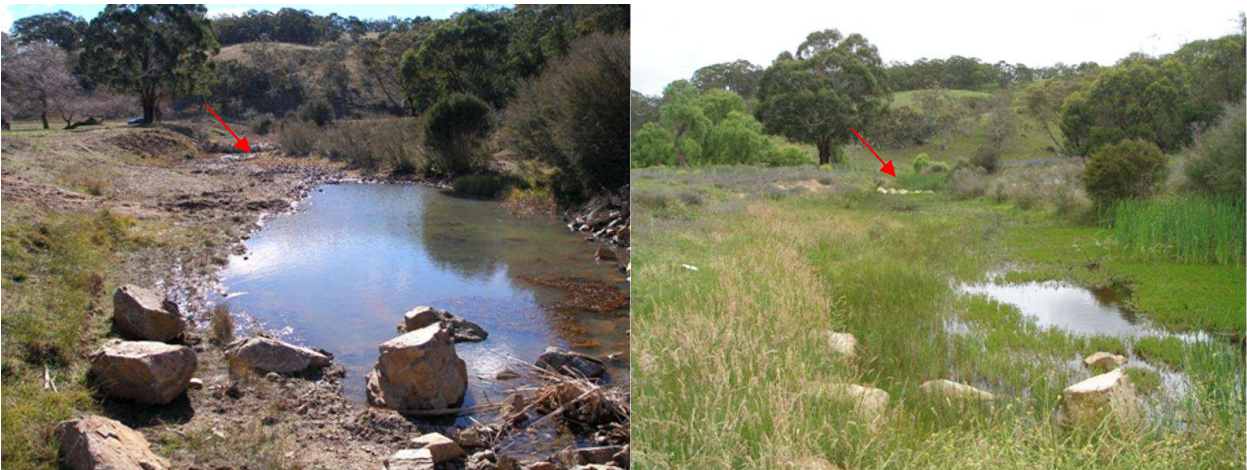
Figure 1.8. View downstream from Weather Station Crossing (LW3) soon after construction, 2006 (left) and Nov 2007 (right). The rock sill is identified by the red arrow. Note the establishment of in-stream vegetation.

There are three rock sill structures on Mulloon Creek at Weather Station Crossing (Figure 1.8, 1.9 and 1.10) and a further three at Willows Complex Crossing (LW5).

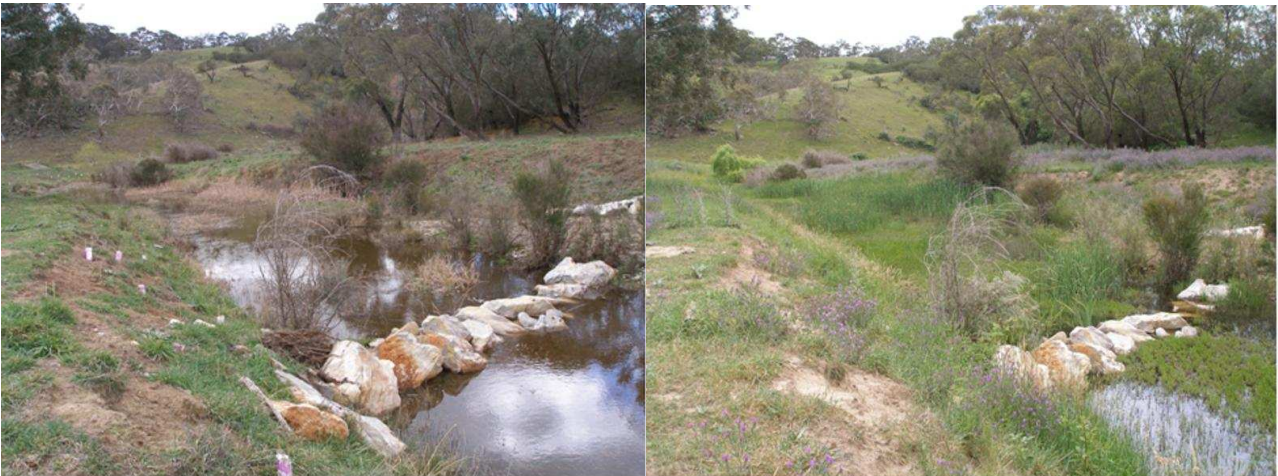
Figure 1.9. Rock sill downstream of Weather Station Crossing (LW3) Jun 2007 (left) and Aug 2008 (right).

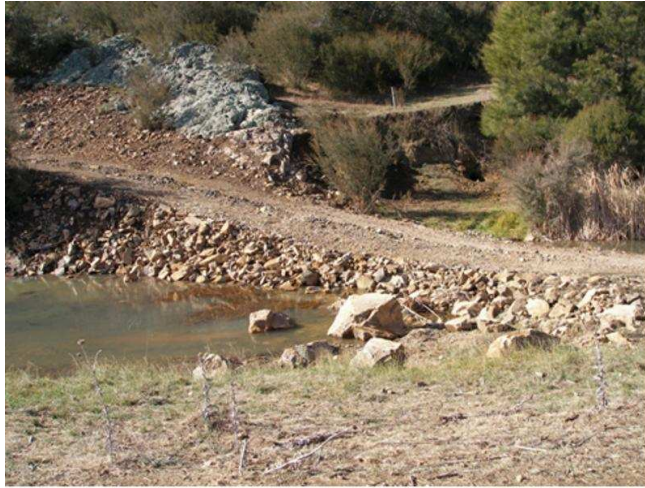
Figure 1.10. Weather Station Crossing (LW4) June 2006, this rock sill was constructed on a natural rock bar.

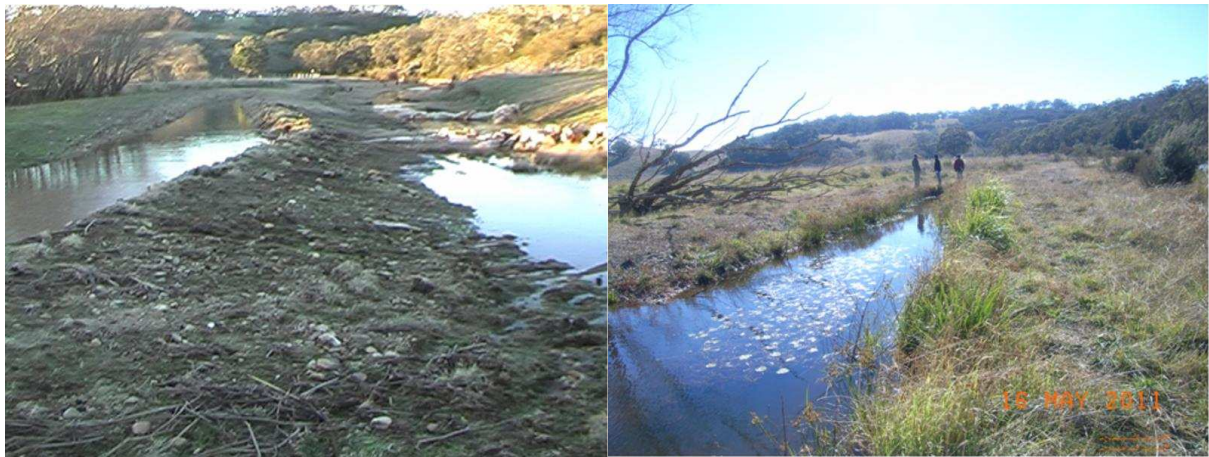
Figure 1.11. Downstream from Willows Crossing Complex (LW5b), Sept 2007 (left). Note rock sills to right of image in main channel. Also in May 2011 (right). Note the vegetation that has become well established in four years

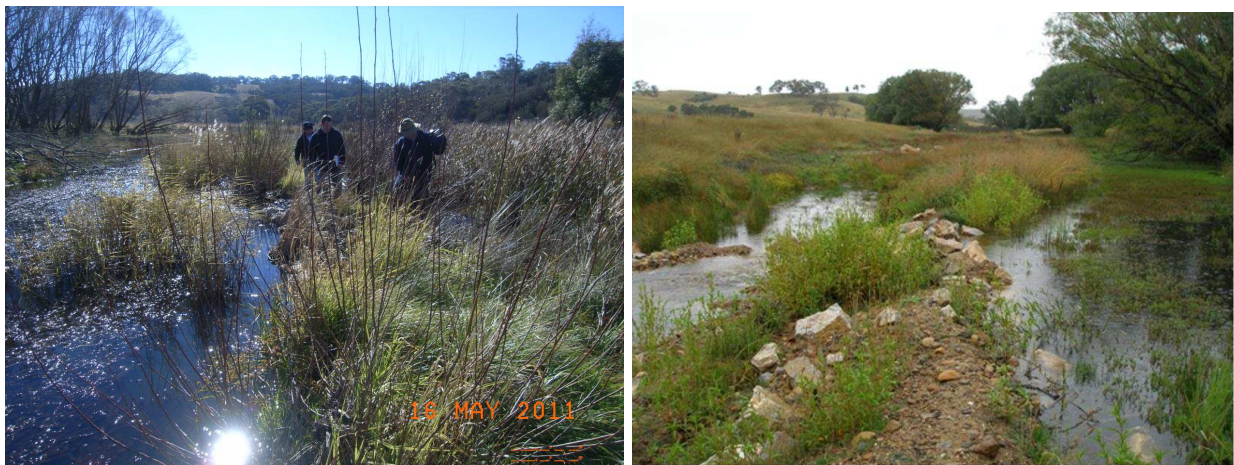
Figure 1.12. Downstream of Willows Crossing Complex (LW5b) at the upstream limit of the structure (left). Note extensive aquatic vegetation growing in main channel on RHS of image. Right photo - Downstream of Willows Crossing Complex (LW5b). Rocks were used to repair some flood damage creating an additional rock sill.

Rapid establishment of vegetation is considered critical to their stability due to the absence of large rock that may be stable during periods of high water flows. The structure at Willows Crossing Complex suffered some damage in 2007 and the resulting break in the bank was repaired with rock, forming a secondary rock sill that has since been colonised by willows, Typha and other plants (see Figure 1.12).

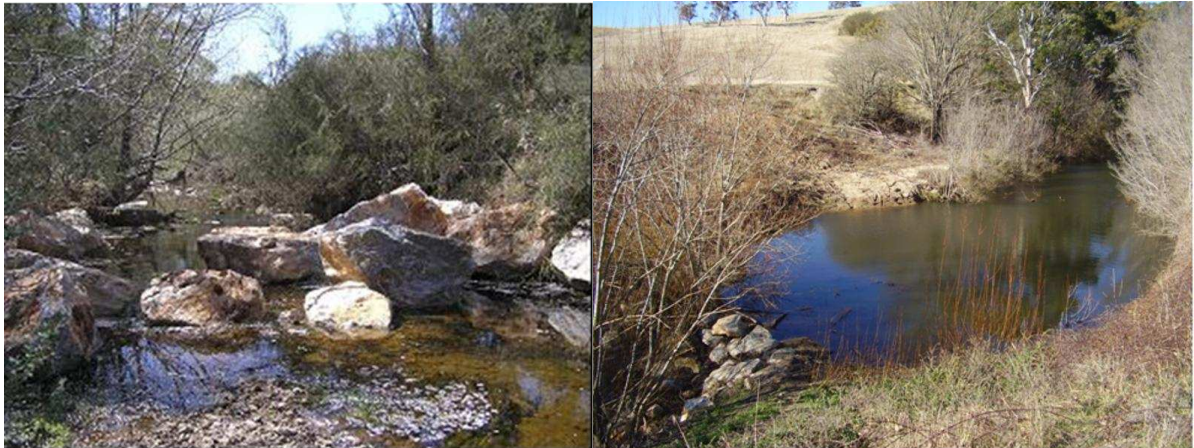
Figure 1.14 'Goldneys Gate' (LW1) (left) is a baffled structure which attenuates river flow. Willy's Ripl (LW13) (right) is a naturally occurring rock bar that was augmented with rock creating an extensive pool

These structures include large boulders (minimum of 1 metre in diameter) that have been placed at 'strategic' choke points within the channel to reduce water velocity by the introduction of channel roughness. Significantly reducing channel capacity, their success relies on the strength of adjacent streambanks, located in places with excellent riparian vegetation and/or within a bedrock confined (or gorge) type channels.

There are two of these structures at the Mulloon Creek site although rocks have been used on nearly all of the structures to achieve different objectives (see Figure 1.14).

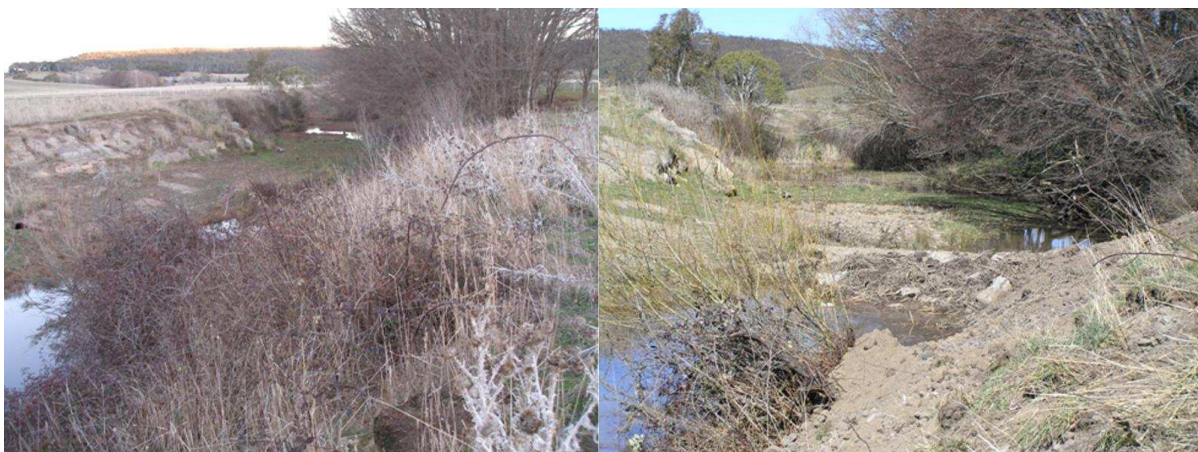
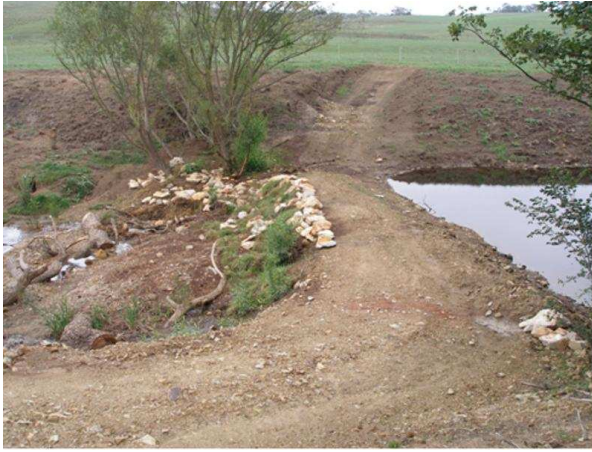
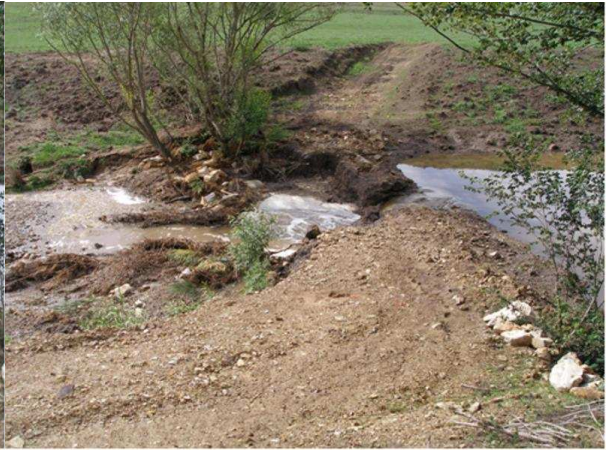
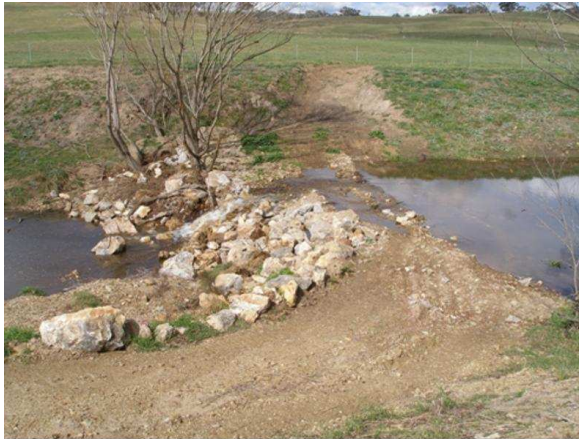
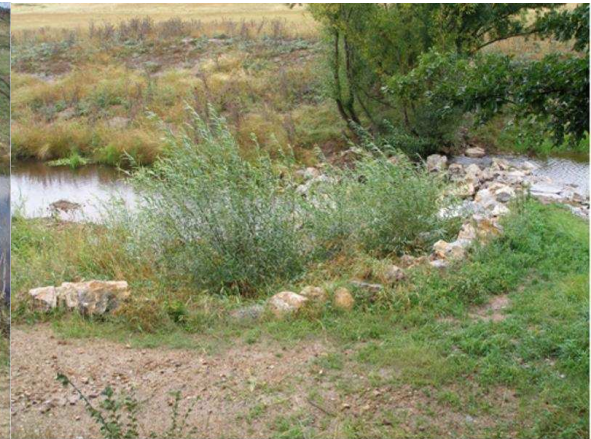
Figure 1.15 – Photographic log of Pokorney's Crossing (LW11).

Before works 2005

Structure when first constructed in August 2006

January 2007

March 2007 showing impacts of a high flow event

August 2007 following repairs and addition of rock

February 2008 with vegetation well established

Pokorney's Crossing was initially constructed as an earthen bank approximately 1m high. This bank was not secured with rock or logs, as per other structures, but relied on the successful establishment of vegetation to provide stability. After construction in August 2006 a high flow event early in 2007 broke through the earthen bank (Figure 1.15). The bank was reinforced with rock and a large willow tree was transplanted to the right bank to provide bank stability. Adjacent banks on both sides were also battered to encourage the establishment of vegetation and groundcover.

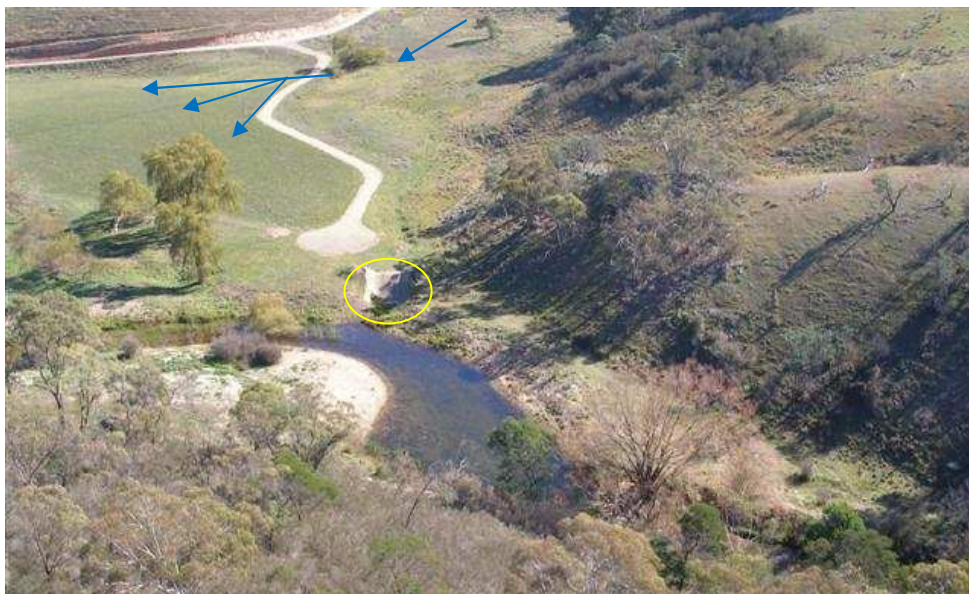
Figure 1.17. Photo from May 2007 showing recovery after reshaping. Water has been directed away from the flume (circled in yellow) onto the fan (new flow shown in blue arrows) and the incised channel has been reshaped. Note that a new track has been constructed that was not present in the previous Figure.

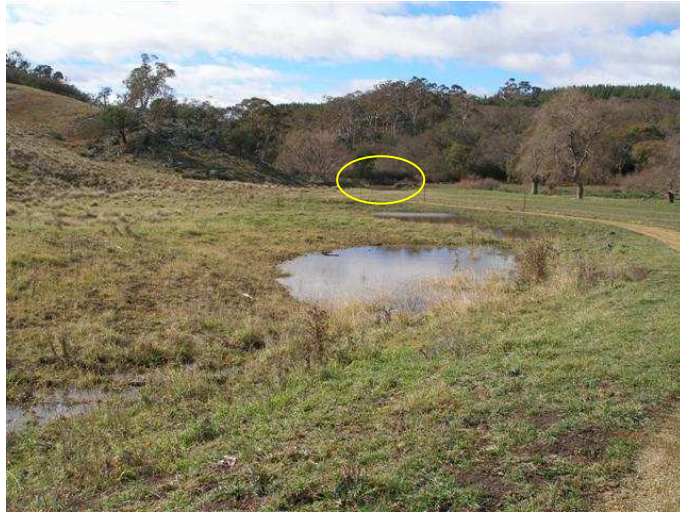
Figure 1.18. Area of previously incised channel now supports a small chain of ponds down to the flume (circled in yellow).

In 1993 a concrete flume was constructed at the 1993 level of Mulloon Creek on the western bank of the creek where Peters Pond is now located (LW2). This flume was constructed to stop active gully erosion working its way upslope into an alluvial fan. A channel still remained above the flume which directed water down the northern edge of the alluvial fan towards the flume (see Figure 1.16). When the NSF trial in-stream work commenced in 2006 this area was redesigned to slow and spread water pulses across the fan. An earthen bank was constructed at the top of the fan to redirect and spread irregular surface flows across the fan (Figure 1.17). The channel between the top of the fan and the flume was reshaped into a chain of ponds. This construction took about half a day of excavator time and required no importation of material. Through this simple intervention the area now supports ponds with good water quality and thick pasture cover (see Figure 1.18).

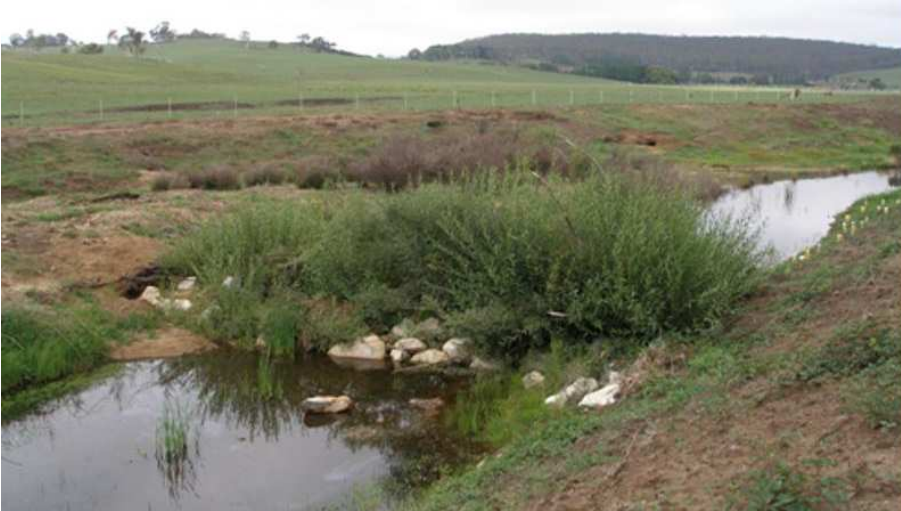
Figure 1.19. Mitchell's Weir showing the integration of vegetation with rocks that make up this structure.

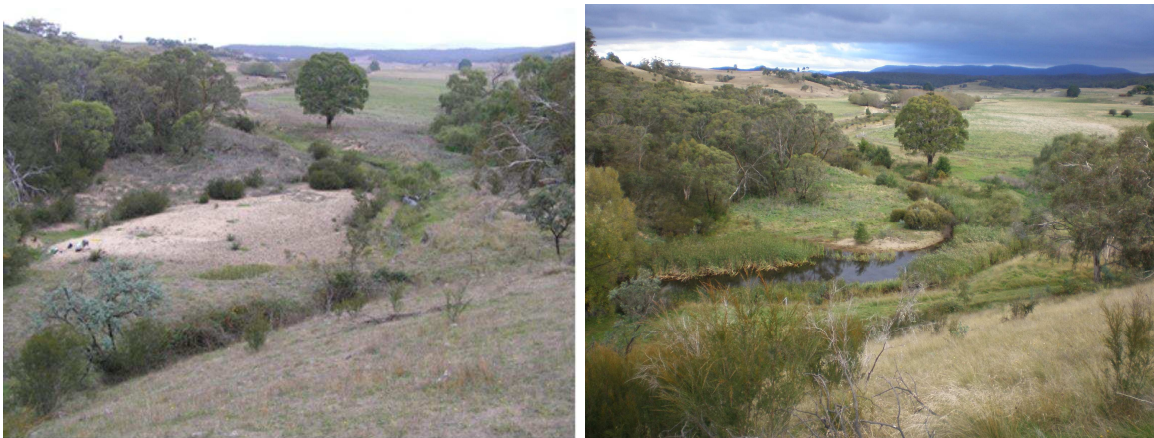
Figure 1.20. Overview of Peter's Pond (P2) prior to works in 2006 April 2011.

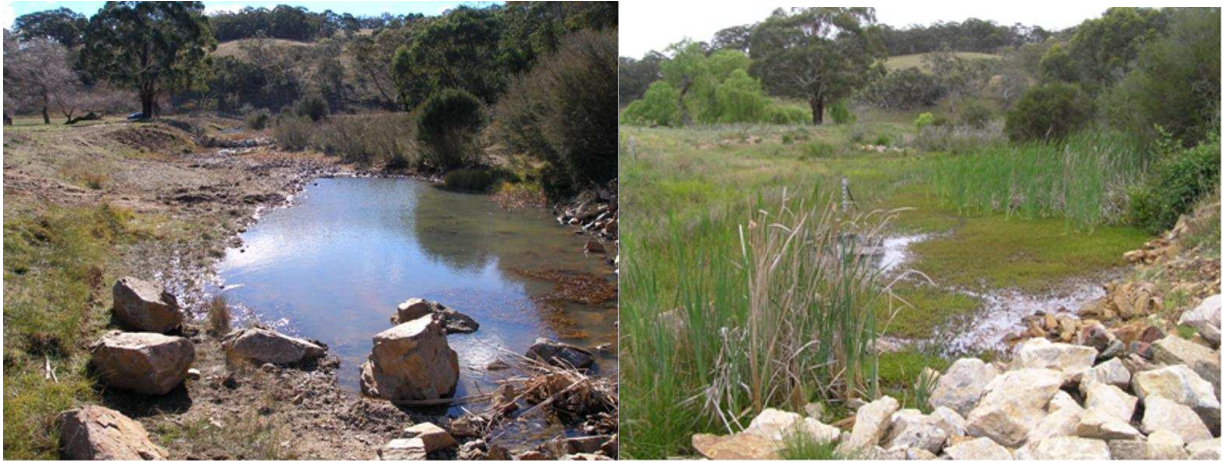
Figure 1.21. View downstream from Weather Station Crossing (LW4) June 2006 and November 2008.

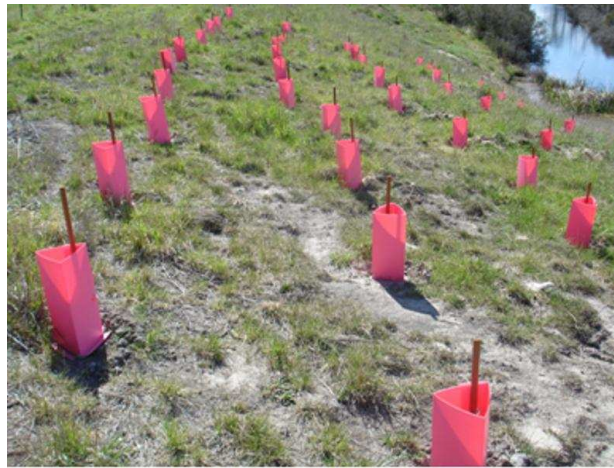
Figure 1.22. Example of planting on the river bank near Poplars Crossing (LW12) in Oct 2008.

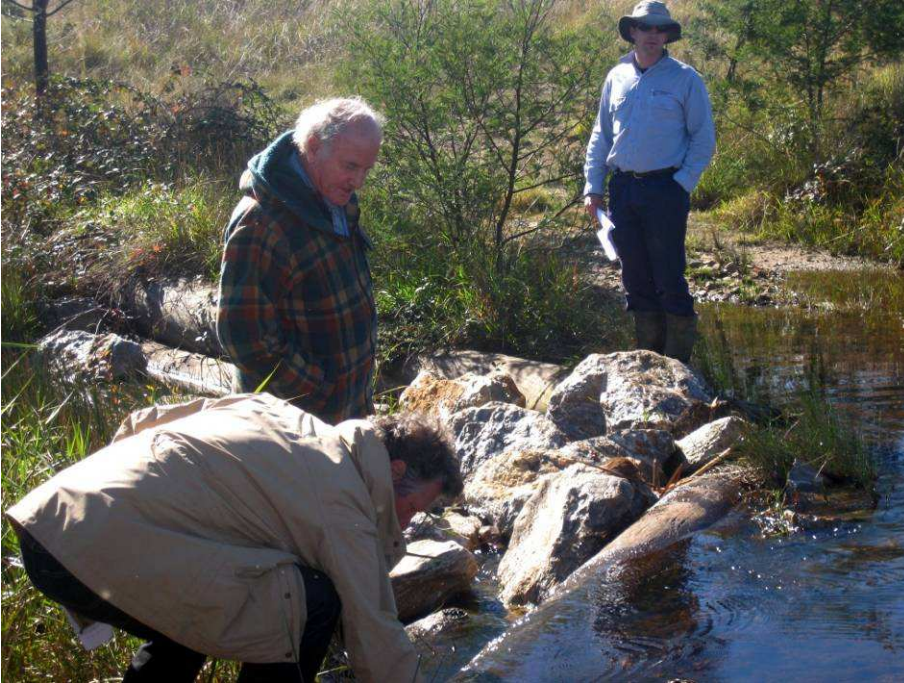
Figure 2.1. A log and limestone leaky weir at Mulloon Creek. L-R: Martin Royds (Chair, Natural Sequence Farming Association), Peter Andrews (Developer, Natural Sequence Farming) and Brad Davies (NSW Land and Property Management)

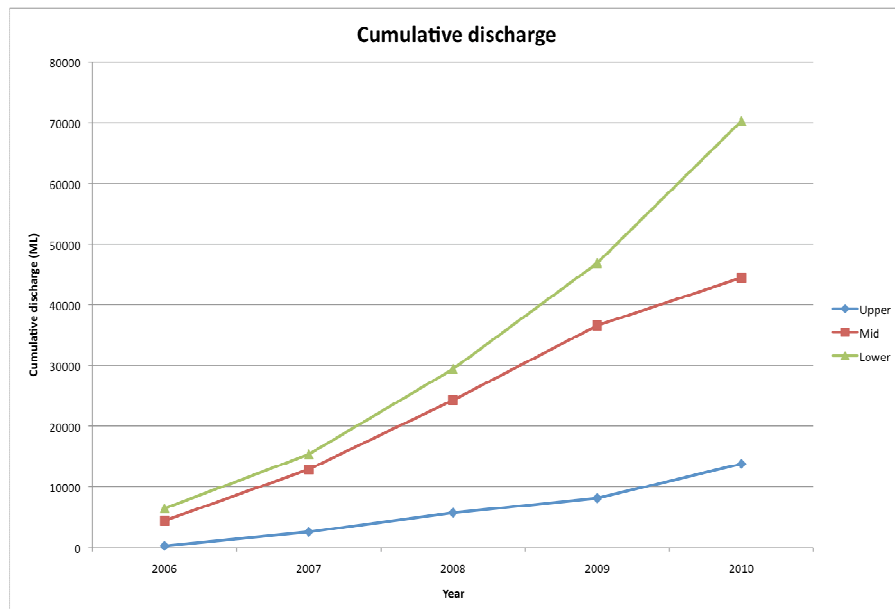
Figure 2.3. This graph shows the volume of water being discharged from the top 23% of the catchment (shown in blue), the additional volume discharged from the next 7% of the catchment (shown in red), and the volume of water discharged from the remaining 70% of the catchment (shown in green).

The graph shows that the volume of water being discharged from the mid (red) and lower (green) catchment areas is increasing over time in comparison with volumes discharged from the upper catchment area (blue). The difference in discharge between the mid-catchment monitoring point and the upper catchment is surprising, given that only an extra 7% of the catchment is contributing to discharge at the mid-catchment monitoring point. The Mulloon Creek NSF structures are situated immediately upstream of the mid-catchment monitoring point. The discharge data suggests that over time, the NSF in-stream structures are increasing the amount of water stored in the mid-catchment area and allowing this water to be slowly released.

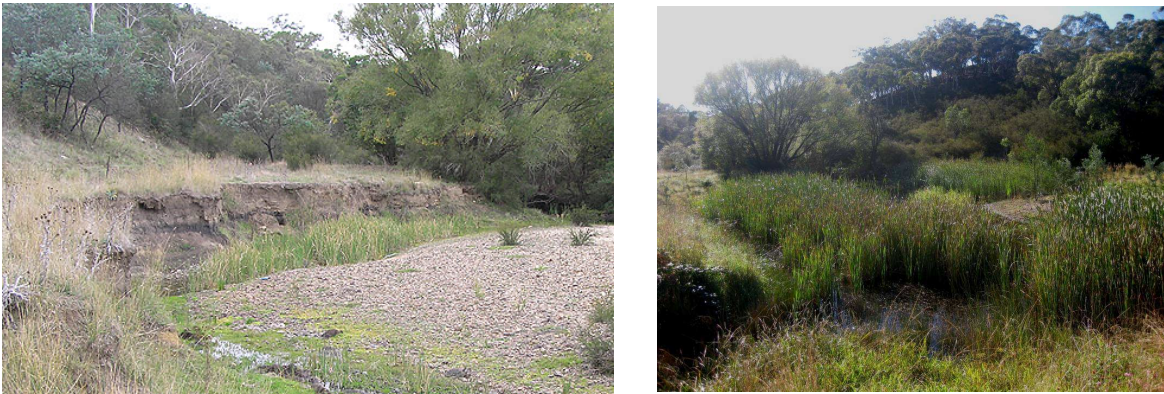
Figure 2.4. Peter's Pond before construction of leaky weir (ca. 2006) and in 2011

After five years, the visual impact of the NSF structures applied at Mulloon Creek can be seen in the photos below. They were taken at *Peter's Pond*, named after NSF developer Peter Andrews. Peter's Pond is the furthest downstream of the 14 NSF leaky weirs constructed at *Mulloon Creek Natural Farms*.

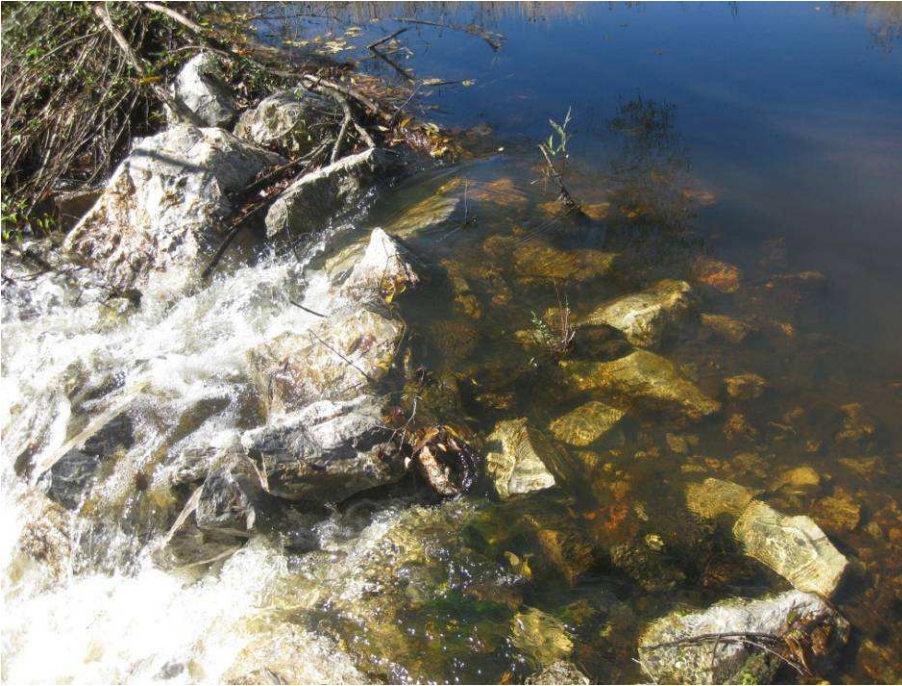
Figure 2.5. Leaky weir comprising rocks, mulch, sediment, plants and micro-organisms.
