GEOGRAPHY BULLETIN

Volume 51 No 1 2019

Dehydration & rehydration of the Australian landscape

Campbell Wilson, The Mulloon Institute

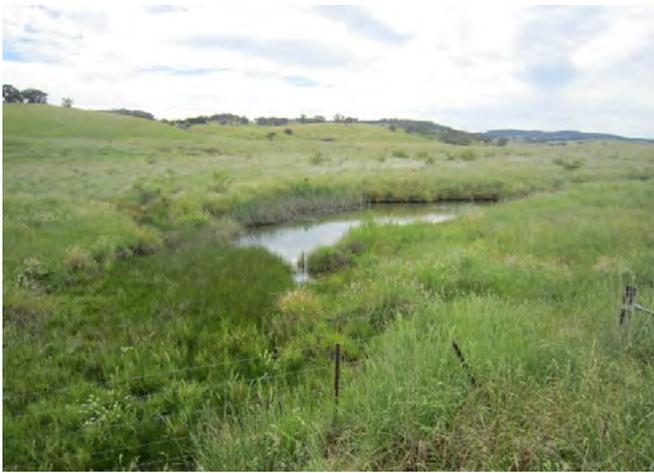
Figure 1: An intact swampy meadow containing a chain-of-ponds. This landscape setting was common at the time of European settlement.

If you were to step back in time and join the early European explorers as they journeyed across the Southern Tablelands of NSW, it is highly likely that if you wandered onto one of the broad valley floors that are typical of the region, you would find a scene similar to that shown in Figure 1.

These systems are commonly referred to as swampy meadows, and are typified by broad floodplains dominated by dense tussocks, sedges and rushes.

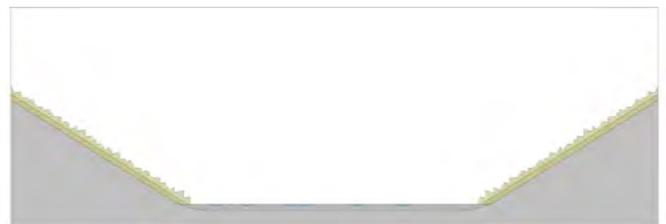
Figure 2: Cold and arid conditions in southeastern Australia during the last ice age significantly reduced vegetation across the landscape. Flash runoff and compromised riparian vegetation resulted, with floodplain systems of the tablelands often completely eroded back to wide beds of alluvial gravels containing braided streams.

During this period, the climate of southeastern Australia was obviously colder, but it was also more arid. This climatic combination significantly reduced overall biomass and groundcover, which meant both rapid runoff from the hills and few plants present to bind and stabilise the valley floors when flash storms arrived. As a result, the extensive floodplains that had built prior to the ice age were almost completely washed away. All that remained on many of the valley floors were wide beds of alluvial gravels, with streams likely to have been braided, containing multiple criss-crossing flow pathways (Figure 2).

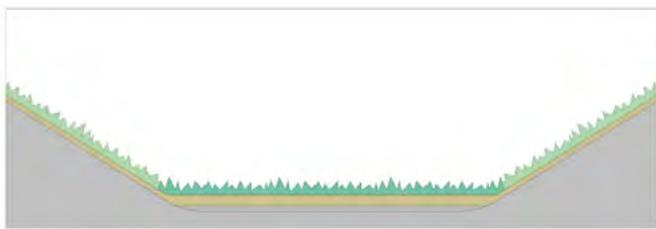
Figure 3: Exiting the last ice age, conditions became far more favourable for plant growth with the increased warmth and moisture available. Vegetation systems colonised the gravel beds and began to trap fine sediment, raising valley floors.

As the earth entered the Holocene just under 12,000 years ago, the warmer and moister climate of southeastern Australia became far more favourable for plant growth. The well-hydrated beds of gravels began to colonise with moisture loving plants. Anything that water rubs up against slows it down, and the roughness provided by the establishing plant systems resulted in the accumulation of fine sediments, and began raising valley floors (Figure 3).

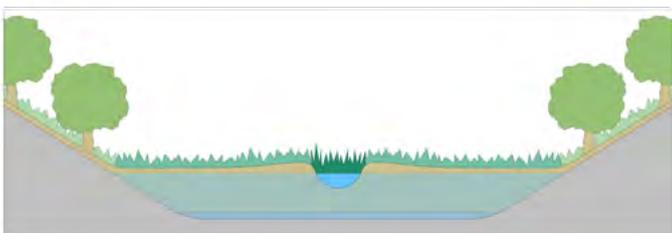
Figure 4: Dense vegetation helps to vertically build sediment and store moisture within the floodplain aquifer, with watertables commonly close to the surface.

An ongoing favourable climate, in combination with consistent land management practices by Indigenous Australians, saw vegetation continue to flourish on the valley floor. The dense tussock and sedge that typify swampy meadows (Figure 1) helped to slow flow and capture even fine sediment, continuing to vertically build fertile soils over time. The considerable flow-resistance within an intact swampy meadow helps to store moisture within the floodplain aquifer, and as a result the watertable is often close to the surface. If a chain-of-ponds is present, this provides a window of insight into the proximity of the watertable to the surface (Figure 4).

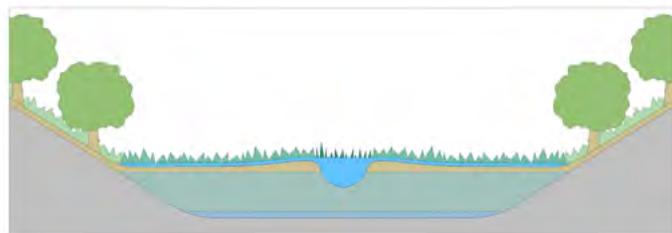
Figure 5: Dense riparian vegetation helps to slow flow, causing it to spread into a passive sheet across the floor of the floodplain.

If channels are present, they tend to be shallow and discontinuous. The dense vegetation flanking these channels, and surrounding ponds if they are present, ensures that if a major runoff event does occur, there is considerable resistance present. This slows the flow, causing it to rise and spill its banks, spreading into a passive sheet across the floor of the floodplain (Figure 5).

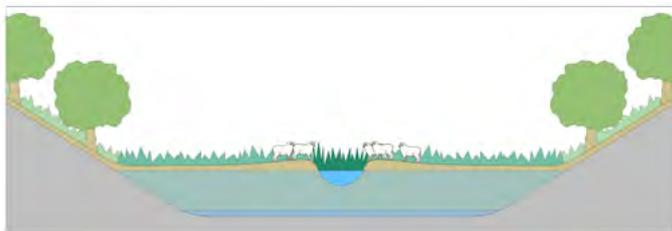
Figure 6: The extensive native grasslands that existed at the time of settlement as a result of skilled indigenous land management were ideal for the development of pastoralism.

The extensive native grasslands that existed at the time of European settlement were a product of the skilled and deliberate use of fire by Indigenous land managers. These grasslands were particularly attractive for sheep production, and chains-of-ponds fed by the alluvial aquifers offered a consistent water supply (Figure 6).

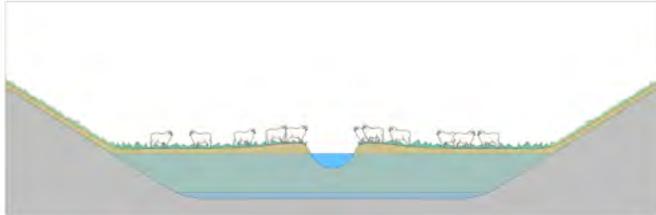
Figure 7: The imposition of a range of European land management practices severely impacted vegetation within a few decades of settlement. The concentration of hard hooved livestock around waterholes particularly impacted vegetative cover in these settings.

The imposition of a range of European land management practices on the older and more fragile Australian landscape had significant hydrological impacts. In particular, the clearance of woody perennials and overgrazing of native pastures due to the proliferation of both domestic livestock and feral animals, resulted in a considerable increase in surface runoff. Vegetation on valley floors was also severely affected by grazing, the impact of hard hooves that were previously absent, and deliberate drainage for cropping and parasite reduction purposes (Figure 7).

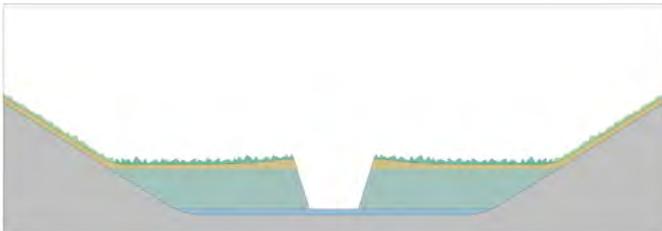
Figure 8: The combination of increased runoff (due to reduced perennial vegetation and severely grazed groundcover) and reduced flow resistance and soil binding root systems on the valley floors, resulted in the widespread incision of swampy meadows.

The combination of increased runoff and streamflow, reduced flow resistance and less stabilising-vegetation resulted in severe and widespread gully erosion like no other time in the last 10,000 years (Figure 8). When a gully forms, it drains the adjacent floodplain aquifer, dropping the watertable down to depth of the new gully floor (Figure 9). Once this occurs, not only is the vegetation on the floodplain surface now at the mercy of

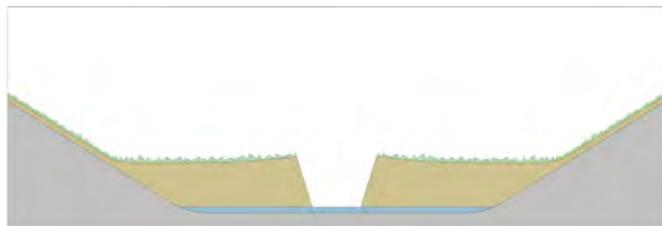
Figure 9: Newly formed gullies acted as drains for the floodplain aquifers, dropping the watertable to the depth of the channel floor.

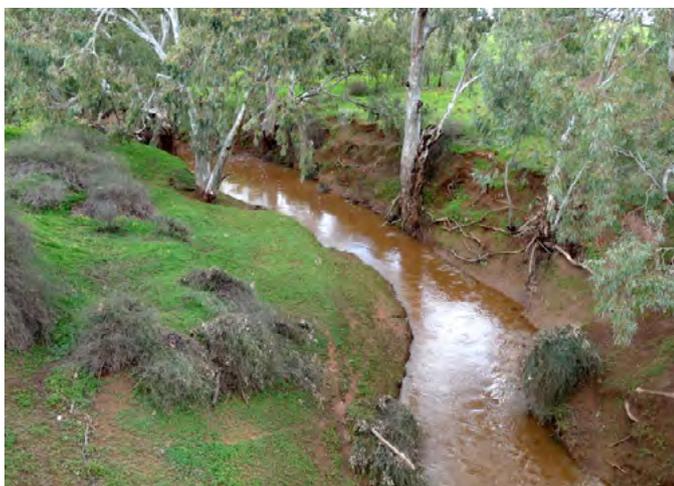
River bank erosion

Figure 10: Within an incised system, even large flows are commonly contained within the channel, resulting in very little interaction of moisture or fertility with the surrounding landscape.

our erratic rainfall patterns, even the largest streamflows are commonly fully contained within the channel, without any surface interaction (Figure 10).

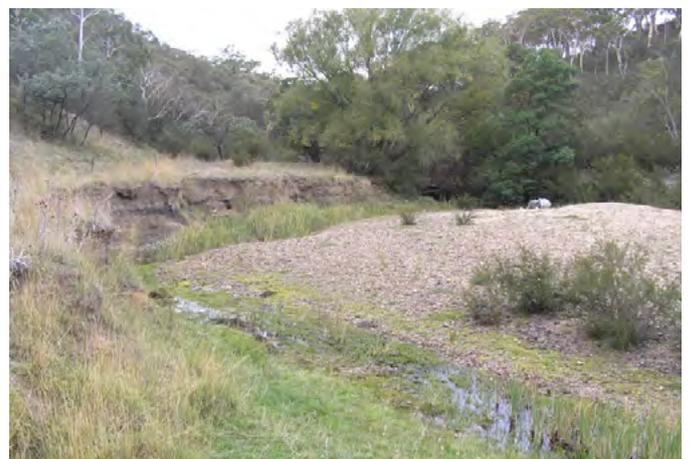
Figure 11: A view towards Peter's Pond in 2006 before work commenced shows eroding banks and minimal vegetation on the site.

An example of this sort of work can be seen in the before and after images in Figure 11 & Figure 12 respectively. These photos are taken at Peter's Pond, one of the structures at the base of a 3 km long riparian restoration project on Mulloon Creek Natural Farms, near Bungedore, NSW. This project was initiated by The Mulloon Institute, with the work overseen by Peter Andrews, the founder of 'Natural Sequence Farming'.

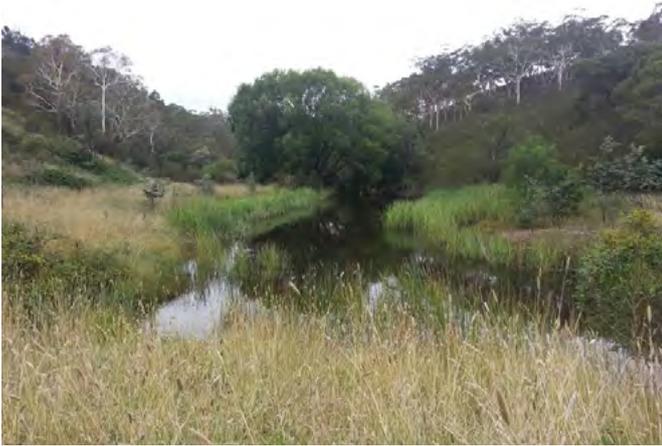
Figure 12: The construction of Peter's weir under the trees in the distance formed a considerable backwater, resulting in a marked increase in both aquatic and terrestrial biomass. This photo is the same orientation as Figure 11.

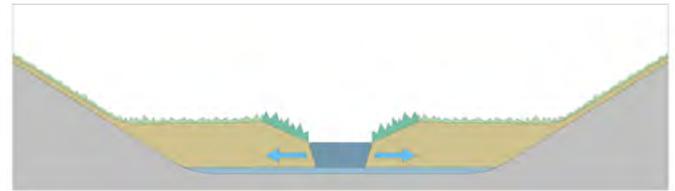
Figure 13: Weirs installed within the incised channel form pools on the upstream side, resulting in recharge of the adjacent alluvial aquifer.

The pools that are associated with the series of structures, often weirs constructed from rocks, logs and stabilising vegetation, increase the hydraulic gradient and result in recharge of the adjacent floodplain aquifer (Figure 13), raising the watertable over time (Figure 14). The increased moisture available to plants on the floodplain surface, as a result of the watertable being to the surface, can result in a considerable increase in primary production on the floodplain surface. The increased vegetation within the channel and on the banks (Figure 12) also enhances the roughness and flow resistance along the system, and provides more opportunity to trap sediment and organic material.

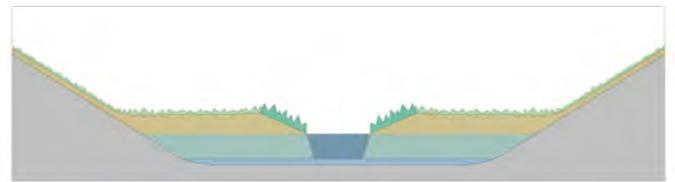
Figure 14: Over time, the watertable within the alluvial aquifer will tend to correlate closely with the level of structures, while increased biomass helps to slow flow and improve water quality and aquatic biodiversity.
