Baseline Rapid Appraisal of Riparian Condition Report

Ira Dudley-Bestow, Luke Peel

September 13, 2021

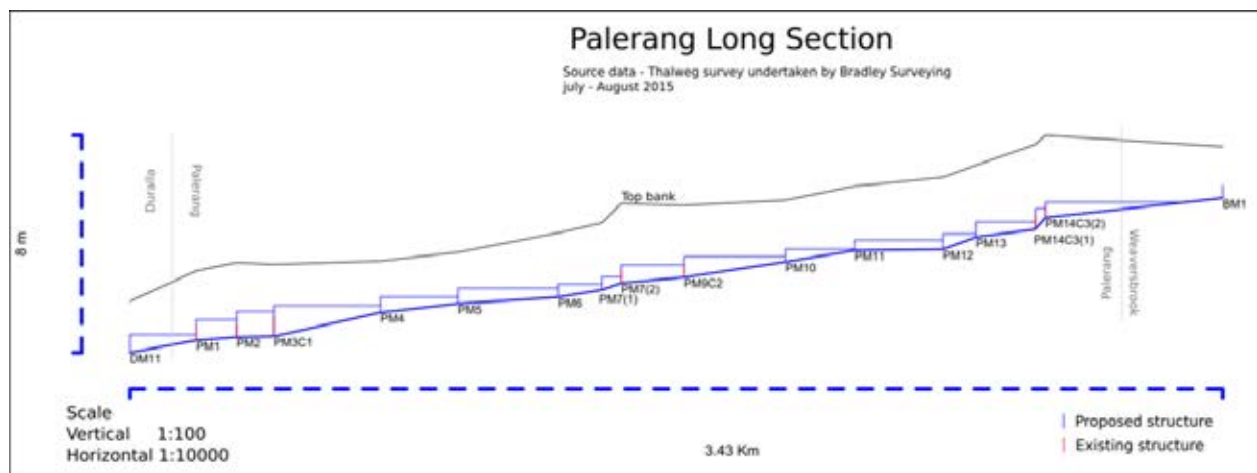
Figure 2: Elevation profile of leaky weirs along the Palerang section of Mulloon Creek. Weirs were installed during 2018-2019. An example of the rehabilitated creek section on a property where RARC surveys were conducted.

Leaky weirs are intervention structures made from rocks and logs used to slow down the flow of water and raise the base water level by creating a chain of ponds. While the volume of water moving through the system remains constant, the rate of movement slows due to the greater cross-sectional area. Consequently, the increased water level reduces the scouring effect of fast moving water and enables a more reliable source of water for flora and fauna during dry periods. This increases vegetation thereby armouring the banks and further reducing the rate of erosion. Other management strategies such as fencing riparian zones from stock and native plantings are combined with leaky weirs to maximise the rate of recovery. Figure 2 depicts an elevation profile of the proposed changes to creek bed as well as relative bank height along the property of Palerang.

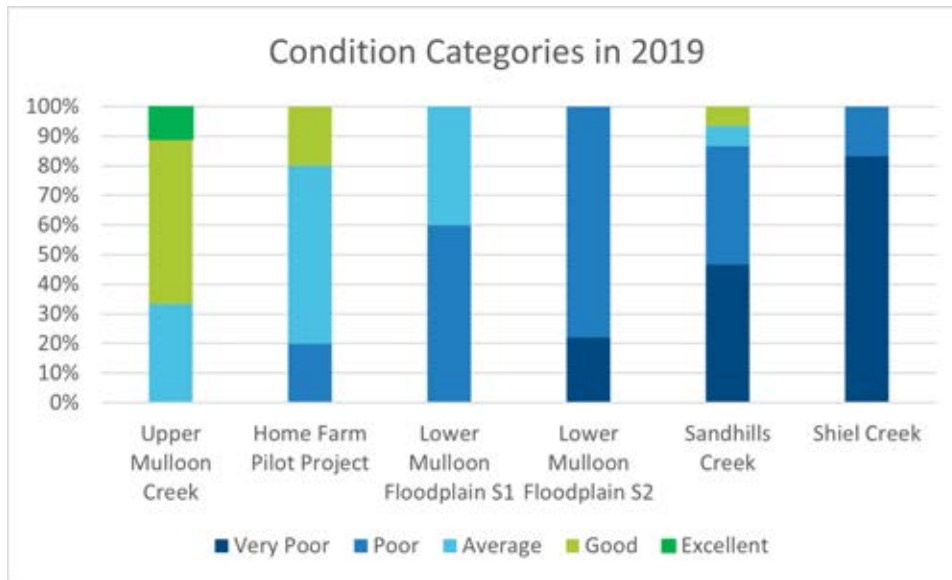
Figure 4: The percentage of sites scoring in each category (<15 very poor, 15-20 poor, 20-25 average, 25-30 good, >30 excellent) of the RARC index for sections of the study area. Values were generated using RARC surveying technique. See Table 4 in Appendix for raw data.

There was considerable variation in the RARC scores across the catchment. Notably, in Figure 4 sites in the lower Mulloon catchment present considerably lower RARC scores than the ones further up the stream. Upper Mulloon Creek contained the only area that had transects in excellent condition (>30 RARC score) and all scores were average or above (see Figure 5). This compares to the lower Mulloon floodplain with 85% of the transects scoring poor (<20 RARC score). Sites in the Sandhills and Shiel Creeks also scored poor or very poor in the majority of transects (Figure 9).

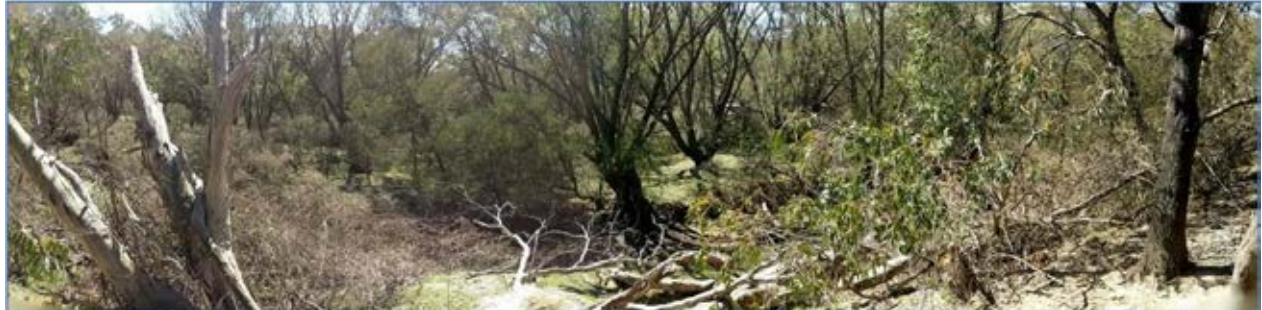
Figure 5: Transect 7 in the upper Mulloon part of the catchment. This site received a RARC score of 26 out of a maximum of 30 in 2019. It received this high score due to it being old regrowth vegetation with a high proportion of natives.

Transects 1-9 in the upper Mulloon catchment are generally in good condition where the riparian zone is rarely grazed and close to large stretches of remnant forest. While the area hasn't had leaky weirs installed, the property has a very high proportion of native vegetation and considerable amounts of large debris. Figure 5 is a representative example of transects in the upper Mulloon catchment.

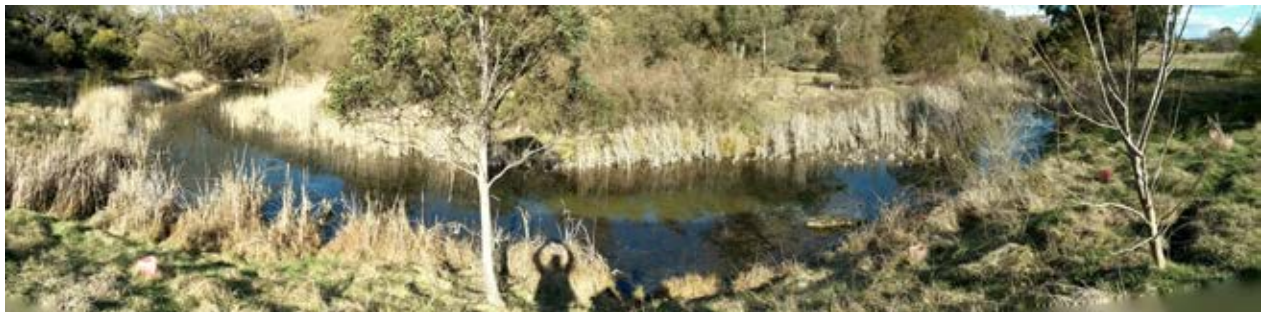
Figure 6: Transect 15 in the MRI demonstration site catchment area. In 2019 this site received a RARC score of 23.5 out of 30.

Transects 11-15 are on the MRI demonstration site which have had leaky weirs installed since 2006 and follow regenerative farming practices. The riparian zone is completely fenced from stock and a large amount of plantings were installed, with a dominant canopy of Weeping Willows (*Salix babylonica*). Transect 11 is in a heavily vegetated site that is rarely grazed and above the leaky weirs. Transects 12-14 are in the alluvial channel. Transect 15 in this area is where the river goes through a gorge and is surrounded by native vegetation. Figure 6 is a representative example of transects in the MRI demonstration site.

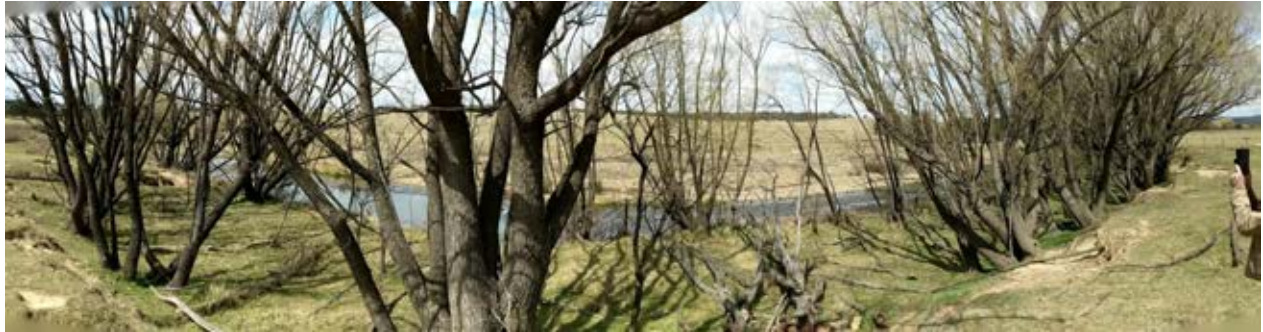
Figure 7: Transect 19 in stage one of the lower Mulloon floodplain. In 2019 this site received a RARC score of 17.5 out of 30.

Stage one transects (T16-T20) go over several properties with different management practices and have a riparian zone with a canopy dominated by Weeping Willows. Transect 17 is in a part of the riparian zone where stock have access to the riparian zone and conventional farming practices are followed. On Transect 18, regenerative farming practices are followed and the riparian zone is fenced from cattle. Transects 19-20 have had leaky weirs installed with considerable plantings in the immediate riparian zone, while the area was recently fenced from stock. Figure 7 is a representative example of transects in the stage one floodplain area.

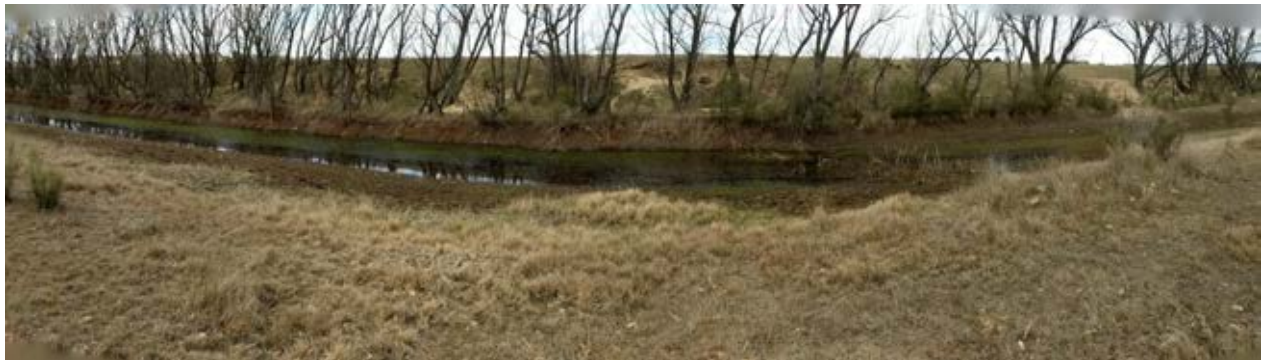
Figure 8: Transect 22 in stage two of the lower Mulloon floodplain at Duralla. In 2019 this site received a RARC score of 16.0 out of 30.

Stage two transects (T21-T29) are all on a wide part of the alluvial channel with some vegetation and a canopy dominated by weeping willows. Transects 21-25 are on a cattle property with a fenced riparian zone following largely conventional management practices. Transects 26-29 are on a chicken property, that occasionally stocks cattle following regenerative farming practices. Figure 8 is a representative example of transects in the upper tributary of Mulloon Creek.

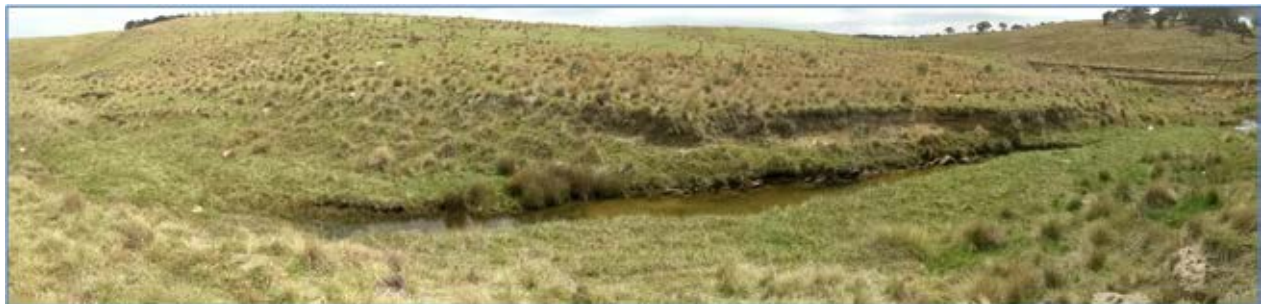
Figure 9: Transect 35 in the Sandhills Creek part of the catchment. This site received a RARC score of 17 out of a maximum of 30 in 2019. This lowish score is largely due to the absence of larger trees to provide suitable habitat.

Transects along Sandhills Creek (T31-T44) are on a smaller creek with with comparatively little vegetation. There are small local stands of *Eucalyptus mannifera*, but otherwise the catchment has comparatively little riparian vegetation and largely runs through grazing enterprises with sections that have direct access to the riparian zone. Figure 9 is a representative example of transects in the upper Mulloon catchment.

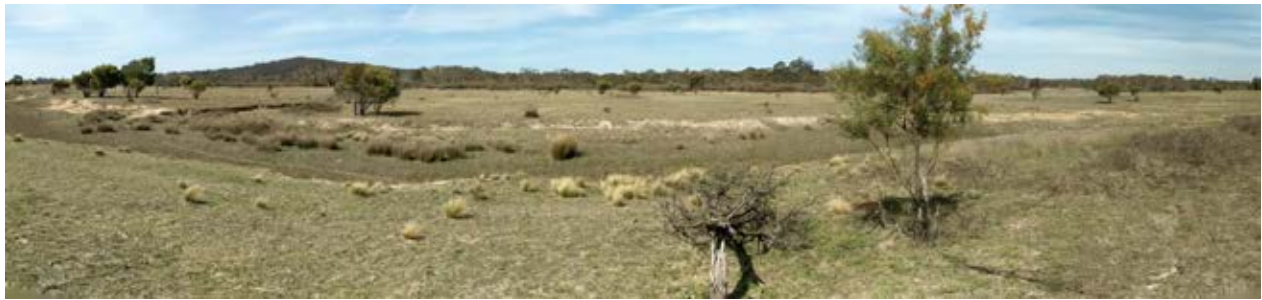
Figure 10: Transect 54 in the Shiel Creek catchment area. In 2019 this site received a RARC score of 10 out of 30.

Transects 52-55 are on Shiel Creek and have very little vegetation in the riparian zone. However what vegetation is there is often native. While very little grazing from stock occurs, it is usually heavily impacted by high densities of kangaroo and deer on the property. Figure 10 is a representative example of transects in the upper Mulloon catchment.

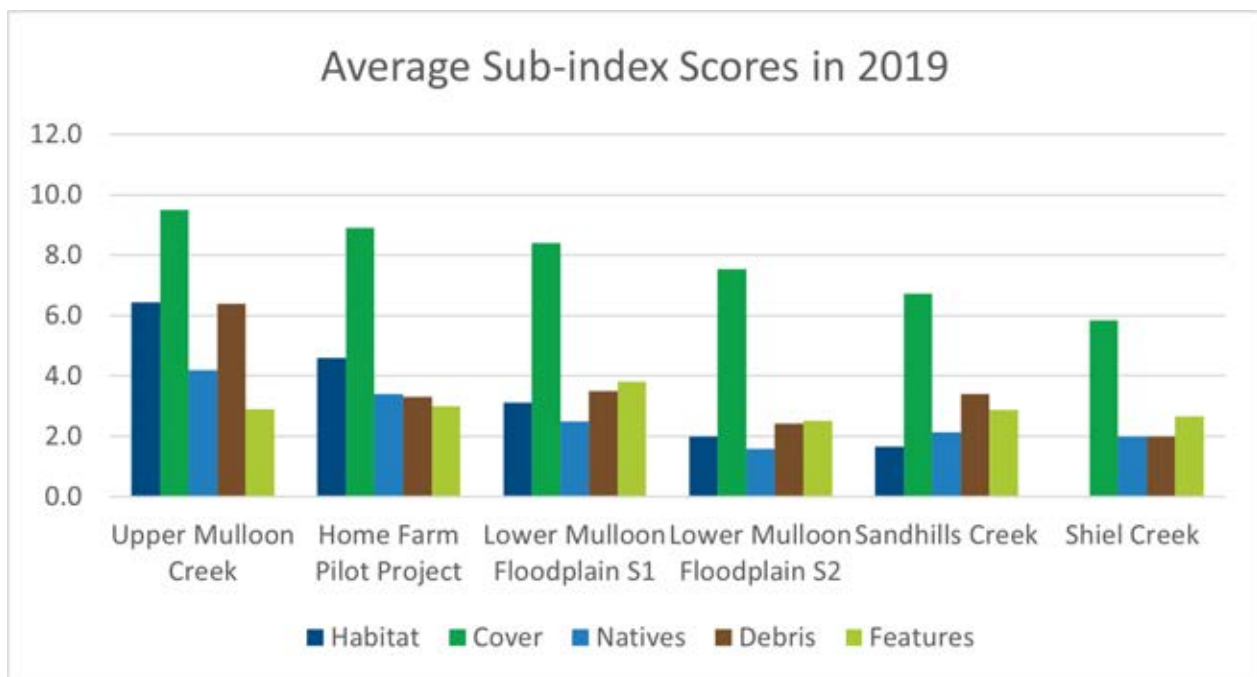
Figure 11: Average sub-index scores for sections of the study area in 2019. Values were generated using RARC surveying technique. Higher scores indicate that the sub-index is in better condition. See Figure 1 for description of sub-index components.

There was also a large degree of variation between each sub-index for the five different catchment areas as shown in Figure 11. This demonstrates where the variation in scores from Figure 4 comes from in terms of the RARC sub-scores. It is clear that habitat, cover, natives, and debris each contribute heavily to the overall scores whereas the feature category displays very little variation across the sites (Table 1 for sub-index categories). Vegetation cover has the highest score across the sub-indices whereas the lowest RARC score category average varies based off management area.

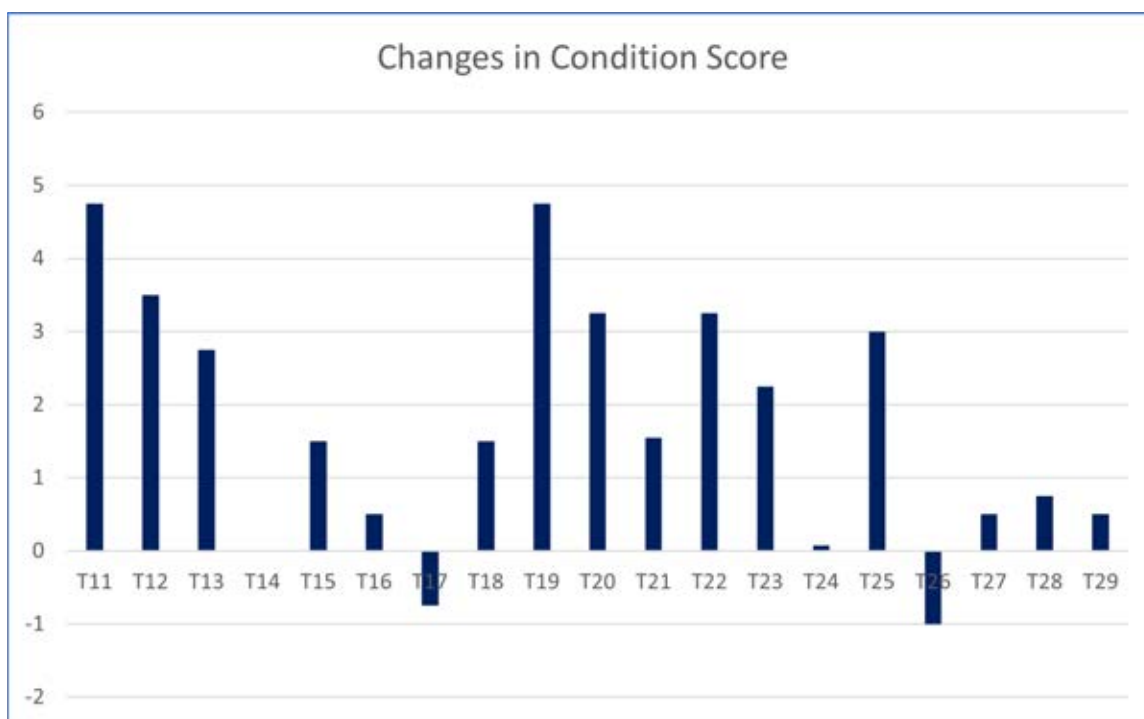
Figure 12: RARC score difference at each of the transects between initial 2017 survey and subsequent 2019 survey. Positive values indicate there was a better RARC score in 2019, whereas negative RARC scores indicate that riparian condition degenerated. Sites T11-T15 are part of the MRI demonstration site, sites T16-T29 are part on the lower Mulloon floodplain area. Raw values were generated using RARC surveying technique and can be found in Table 3 Appendix.

Out of the 19 transects, 16 had a higher RARC score in 2019 than 2017 as is depicted in Figure 12. Transect 11 and Transect 19 increased the most with an increase of 4.75. Whereas Transect 26 had the greatest decrease, with a decrease of 1.00. The average change across all transects was an increase of 1.72. The average change in RARC score on the MRI demonstration site (T11-T15) was 2.54, while the average change in the lower Mulloon floodplain (T16-T29) area was 1.50. Table 2 depicts the standard deviation and averages of the changes in each sub-index. Cover had the highest average change of 0.649 with a standard deviation of 1.04 whereas habitat had the lowest average change of -0.212 with a standard deviation of 1.21.
