# DRAFT REPORT FOR THE MONITORING OF THE MULLOON CREEK NATURAL SEQUENCE FARMING DEMONSTRATION

Australian Government National Landcare Program Funding # 56319

MULLOON CREEK NATURAL FARMS,  
KING'S HIGHWAY, VIA BUNGENDORE

June 2008

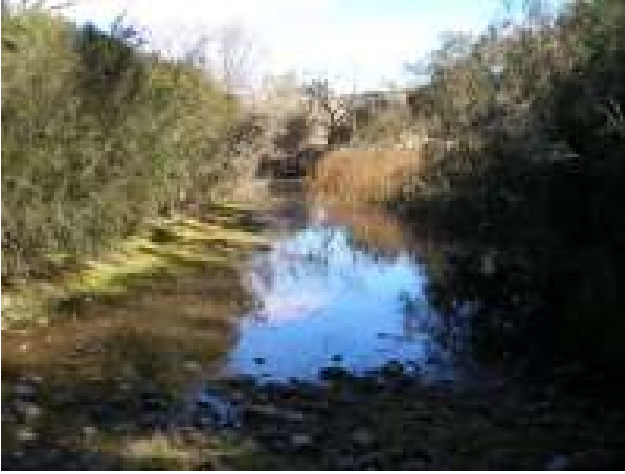
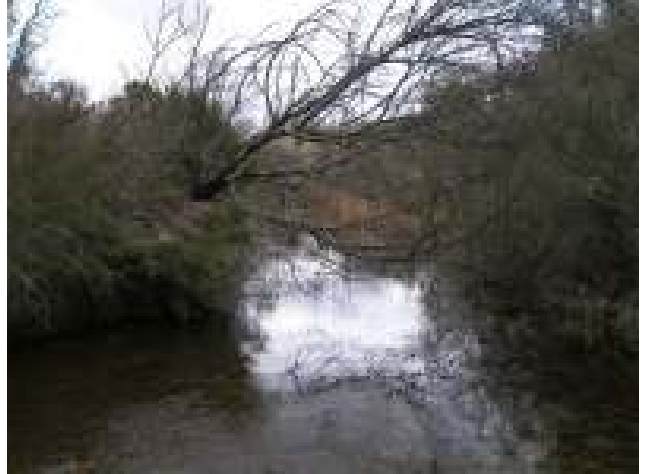
## Leaky Weir 1 (LW1 Goldney's Gate) and Pond 1

**Location:** Most northerly Pond weir on the property. .

**Description:** Three large boulders arranged in a triangle

Pond 1 is not associated with LW1. LW1 is a de-energising leaky structure approximately 50 metres north from tP1.

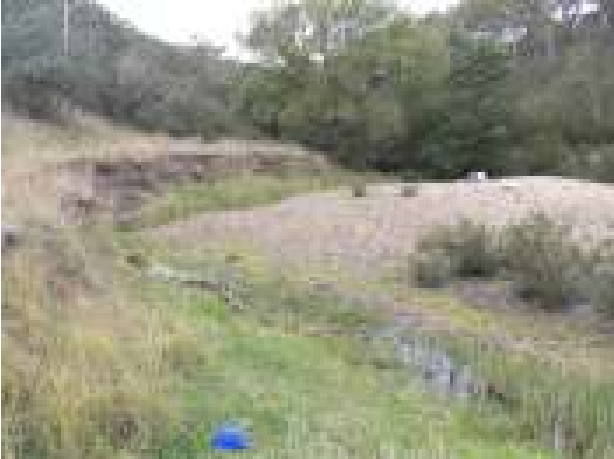
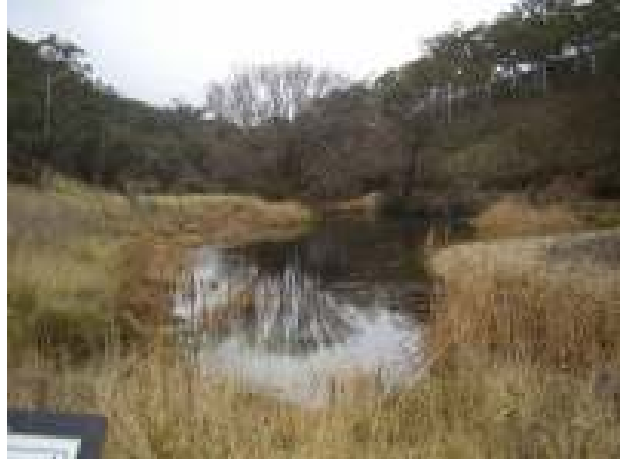
## Leaky Weir 2 (LW2 – Peter’s Weir) and Pond 2 – “Peter’s Pond”

**Description:** Rock weir supported by large willow tree and Cumbungi. Bank shaping and planting

Pond depth is currently 220% greater than original depth prior to leaky weir installation. The trend is demonstrating that this is moderately rising.

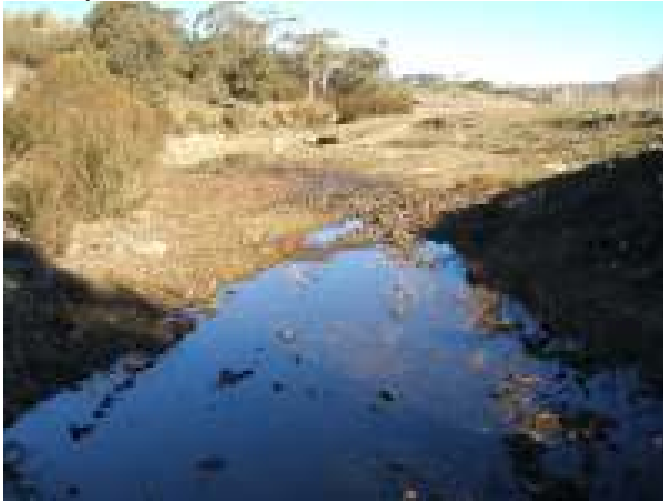
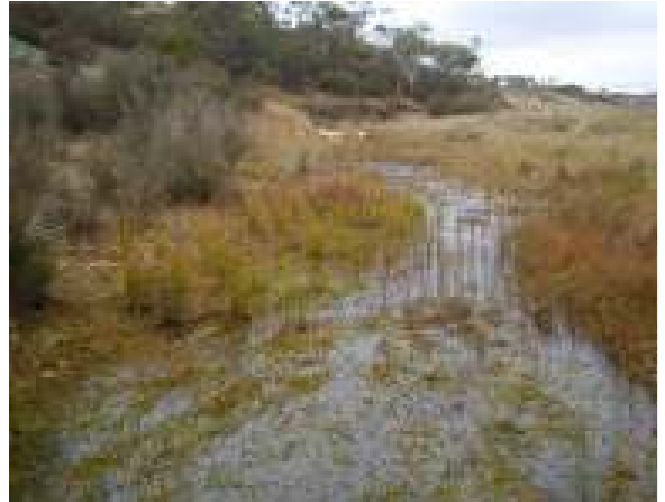
## Leaky Weir 3 (LW3), Pond 3a and 3b

**Description:** Rock baffles

Pond depth is currently 190% greater than original depth prior to leaky weir installation. The trend is demonstrating that this is rising.

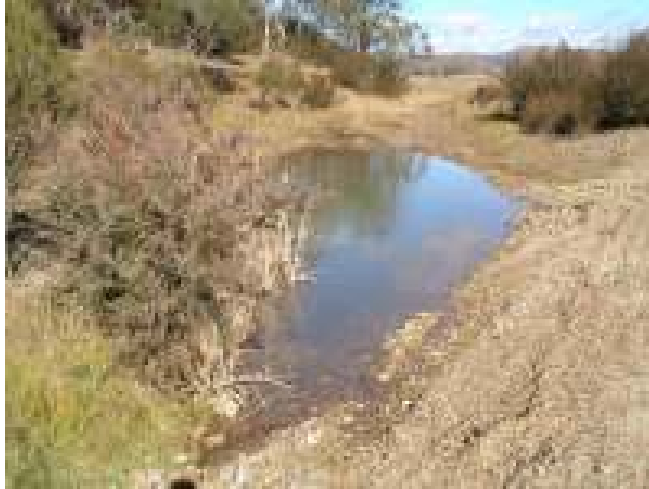
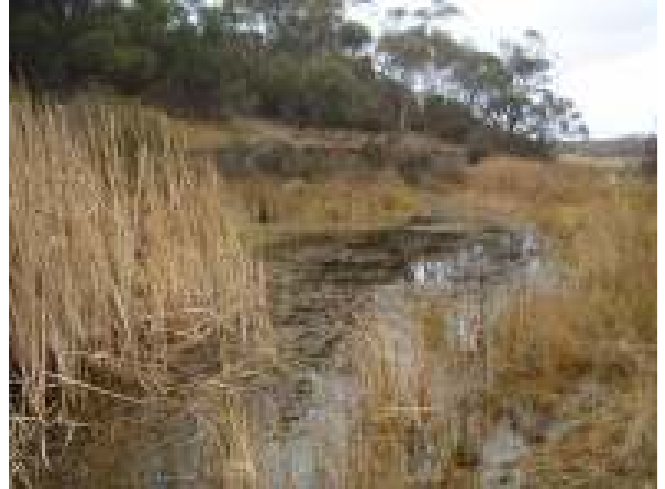
## Leaky Weir 4 (LW4), Pond 4 – “Weather Station Crossing”

**Description:** Rubble crossing

Pond depth is was last assessed 30/11/2007 and it was 0 cm depth. This site will have a manual measuring gauge installed in mid June 2008.

Obs: The pond maintains water levels for most of the year.

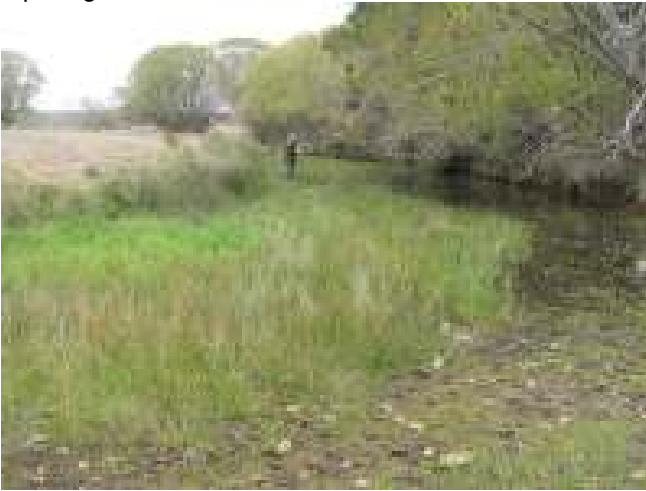
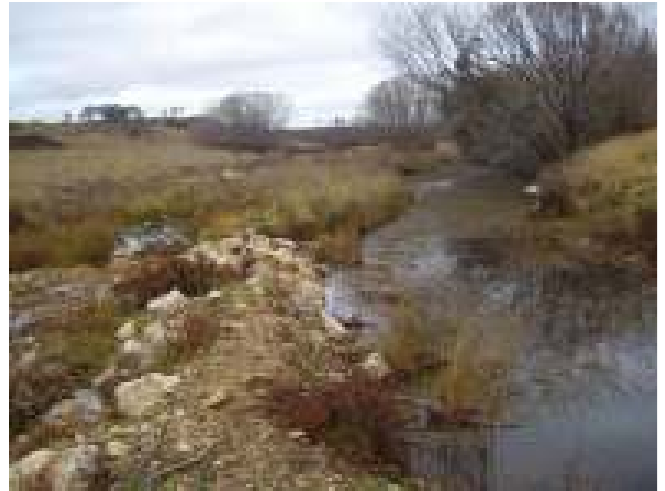
## Leaky Weir 5 (LW5), Pond 5

**Description:** two constructed side channels, pond lengthening, two rock baffles and a constructed pond. Bank tapering.

Pond depth is currently 163% greater than original depth prior to leaky weir installation. The trend is demonstrating that this is rising slightly.

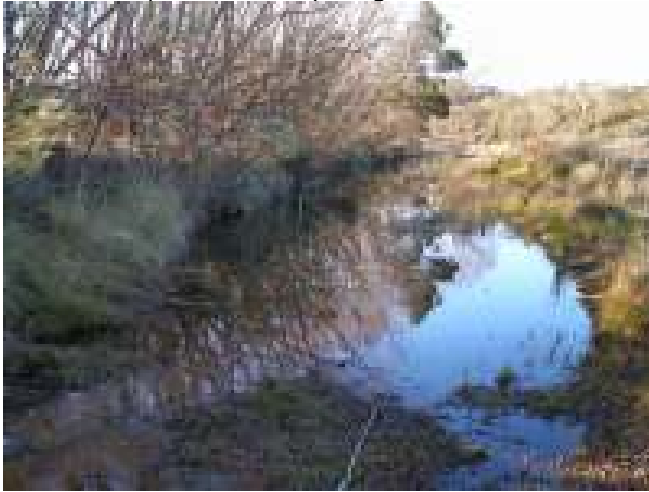
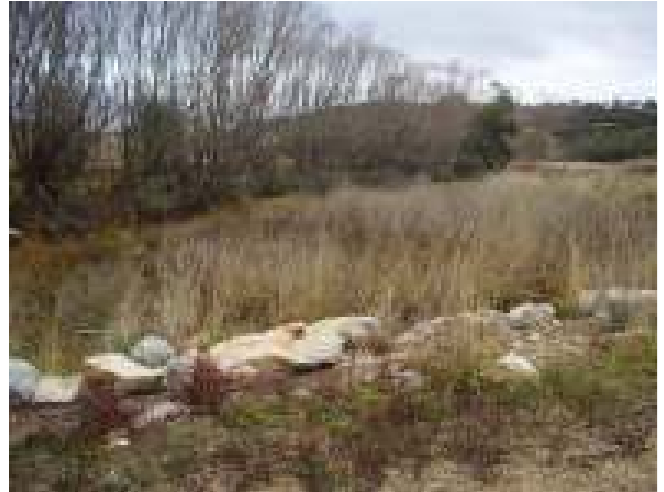
## Leaky Weir 6 (LW6), Pond 6 – “Willows Complex Crossing”

**Description:** Three weirs, two constructed side channels, pond lengthening, two rock baffles and a constructed pond. Bank tapering.

Pond depth is currently 135 cm, which was 0 cm prior to leaky weir installation. The trend is demonstrating that this is moderately rising.

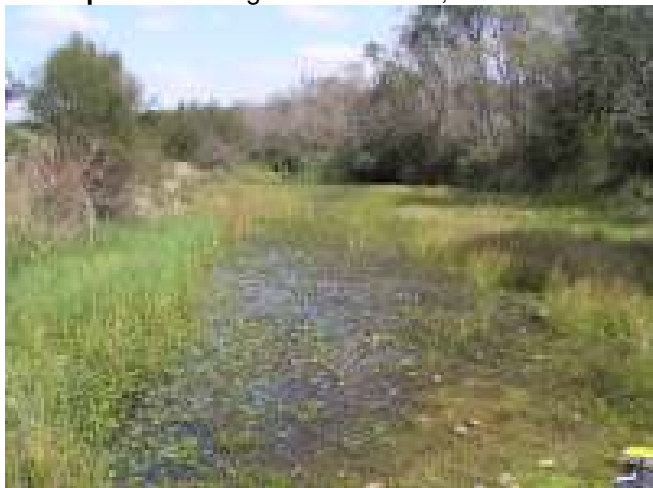
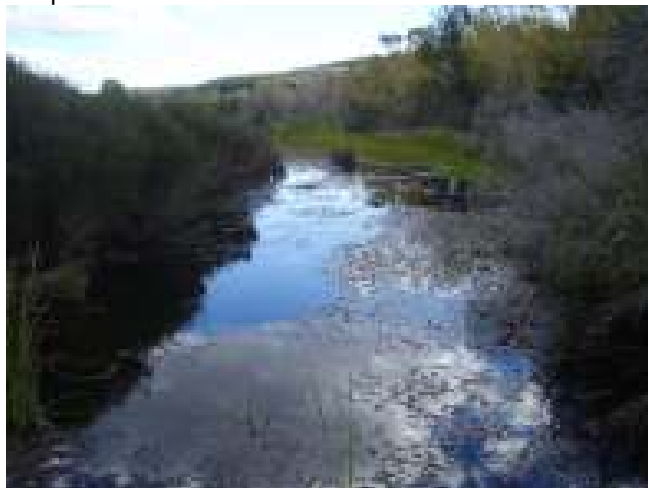
## Leaky Weir 7 (LW7a and LW7b), Pond 7 – “Williams Wallow”

**Description:** Two log and rock weirs, a constructed levy and pond.

Pond depth is currently 155% greater than original depth prior to leaky weir installation. The trend is demonstrating that this is rising slightly.

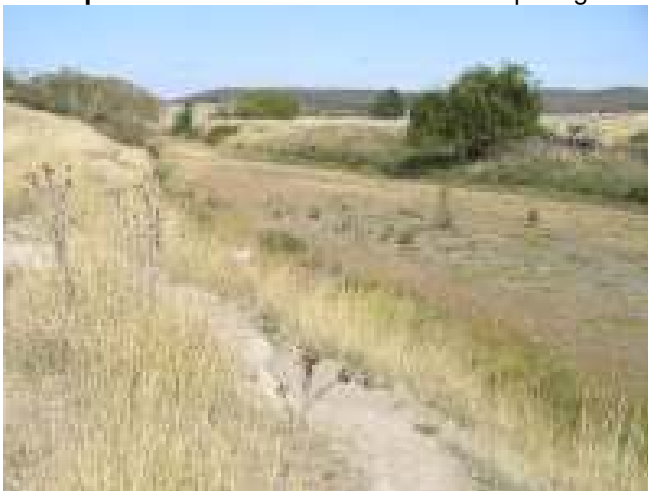
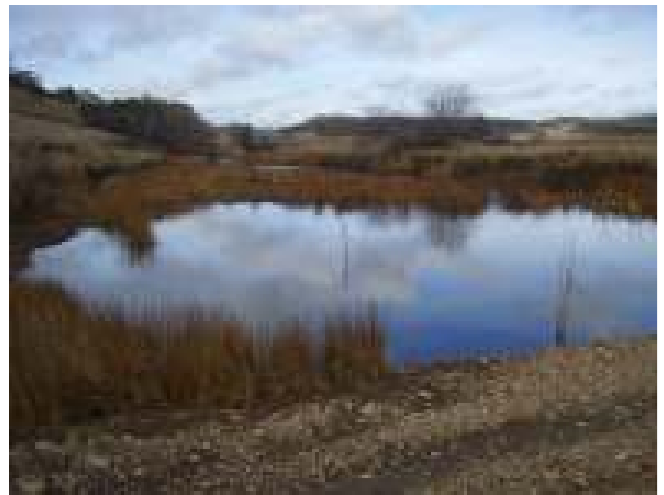
## Leaky Weir 8 (LW8a + b = c), Pond 8 "Triple Ponds Crossing"

**Description:** Series of three weirs. Bank tapering

Pond depth is currently 150 cm, which was 0 cm prior to leaky weir installation. The trend is demonstrating that this is steadily rising.

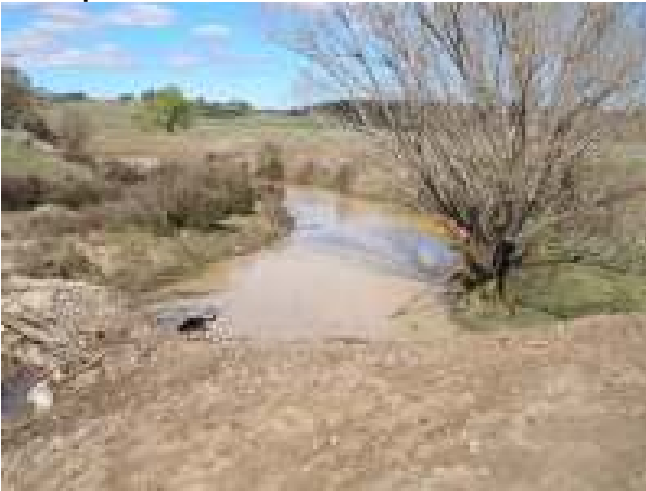
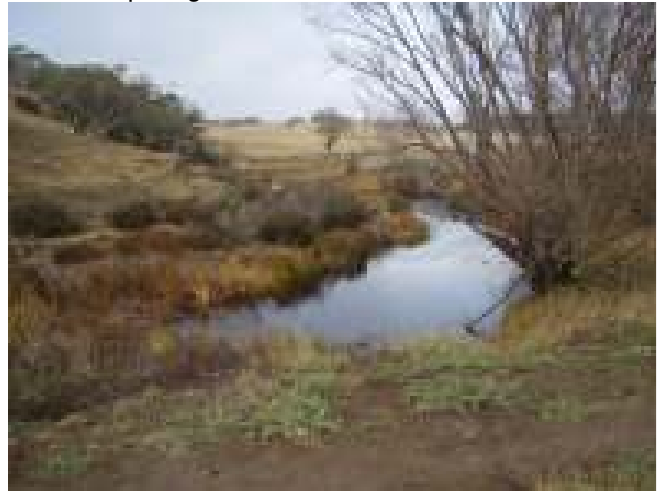
## Leaky Weir 9 (LW9), Pond 9 – “Platypus Pond”

**Location:** Pond upstream of Triple Ponds crossing, immediately downstream of ‘Go Back Way Back’ crossing  
**Description:** One weir made from rubble and willow branches. Bank tapering.

**Pond depth:**  
 Pond depth is currently 150 cm, which was 0 cm prior to leaky weir installation. The trend is demonstrating that this is steadily rising.

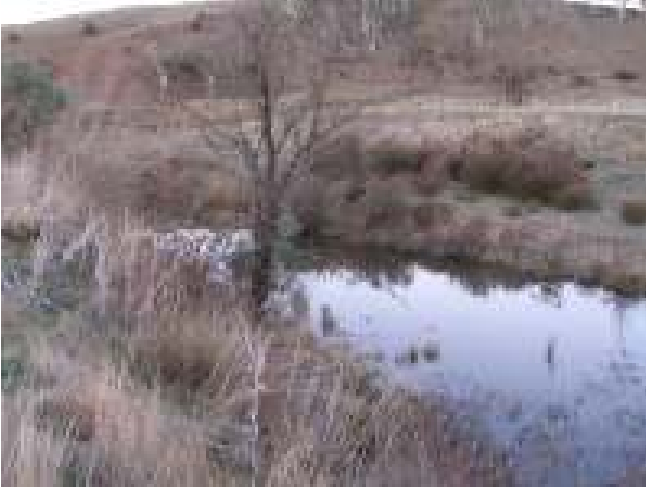
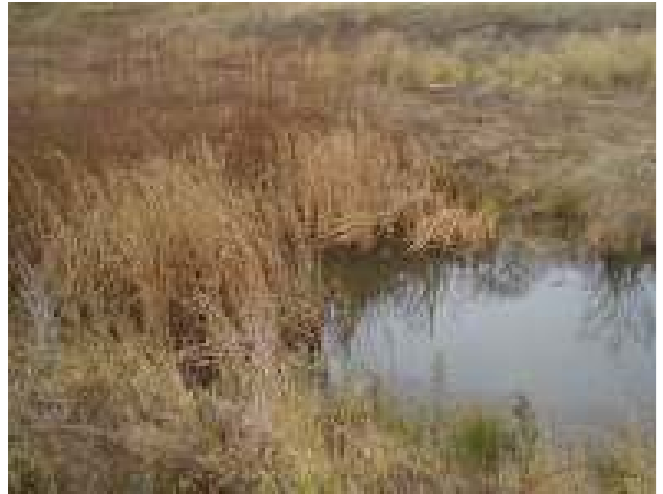
## Leaky Weir 10 (LW10), Pond 10 – “Mitchell’s Weir”

**Location:** Pond directly upstream of ‘Go Back Way Back’ crossing  
**Description:** Rock and rubble piled up around a felled willow tree

Pond depth is currently 1250% greater than original depth prior to leaky weir installation. The trend is demonstrating that this is rising slightly.

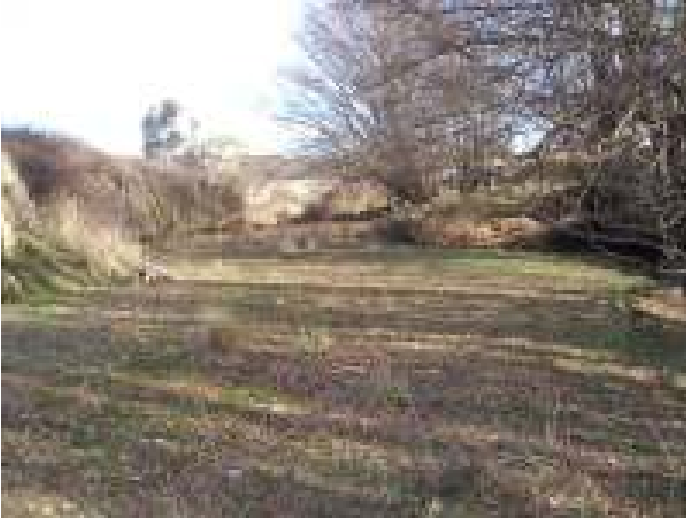
Photo log: 2006

## Leaky Weir 11 (LW11) – Porkoney’s Pond Crossing, Pond 11

**Description:** Rock, cobble, soil and vegetation weir

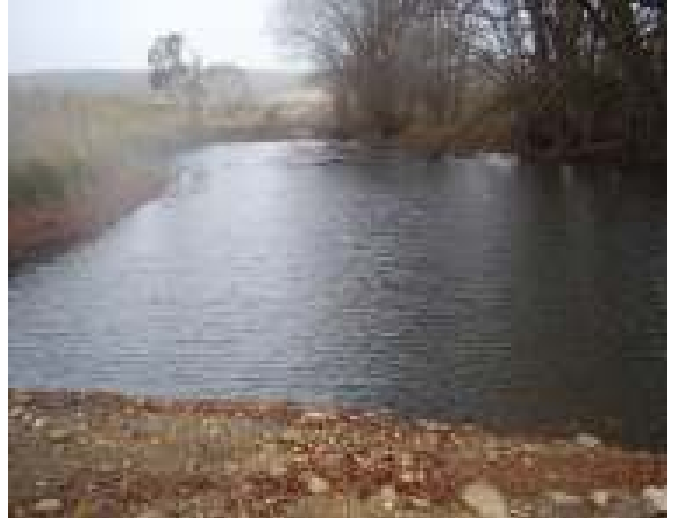
June 2008

Pond depth is currently 2000% greater than original depth prior to leaky weir installation. The trend is demonstrating that this is rising slightly.

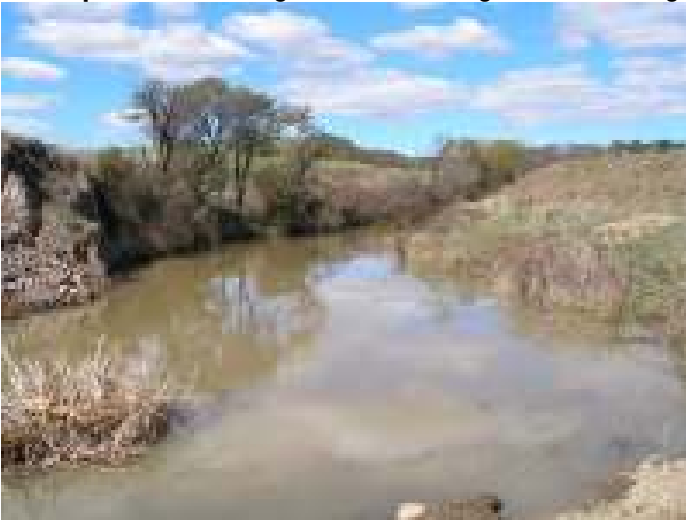
Photo log: 2006

**Description:** Rocks, logs, rubble and vegetation crossing. Low flow directed through pipe

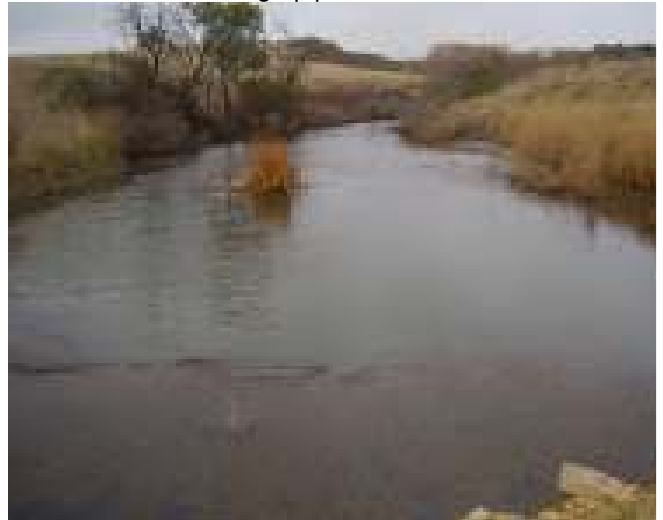
June 2008

**Pond depth:**  
 Pond depth is currently 220 cm, which was 10 cm prior to leaky weir installation (rise by 2200%). The trend is demonstrating that this is steadily rising.

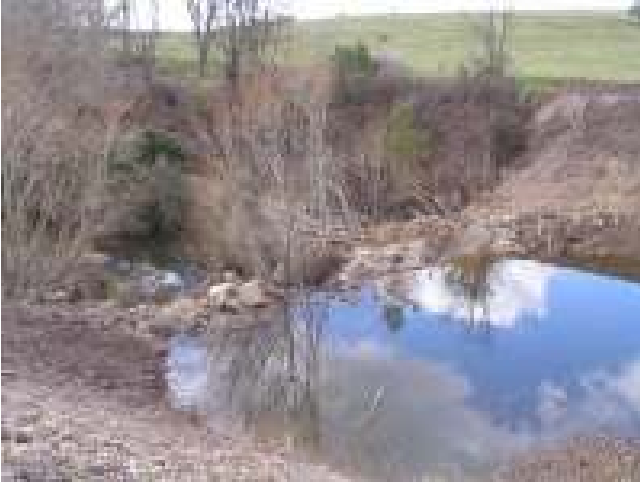
Photo log: August 2007

**Description:** Limestone Outcrop

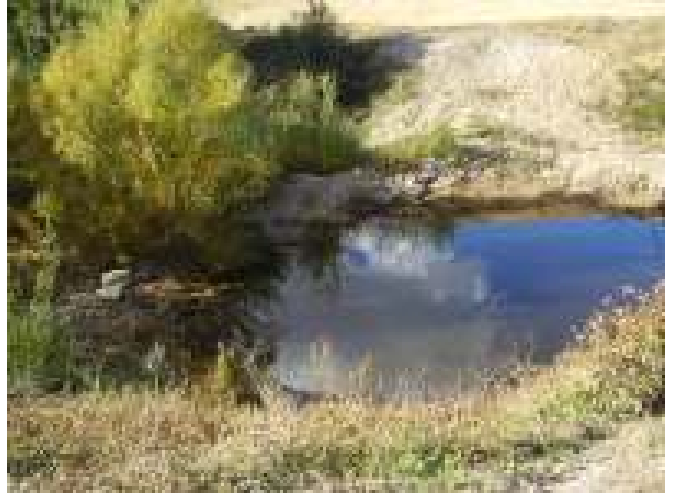
June 2008

**Pond depth: No pond depths have been taken from this site**

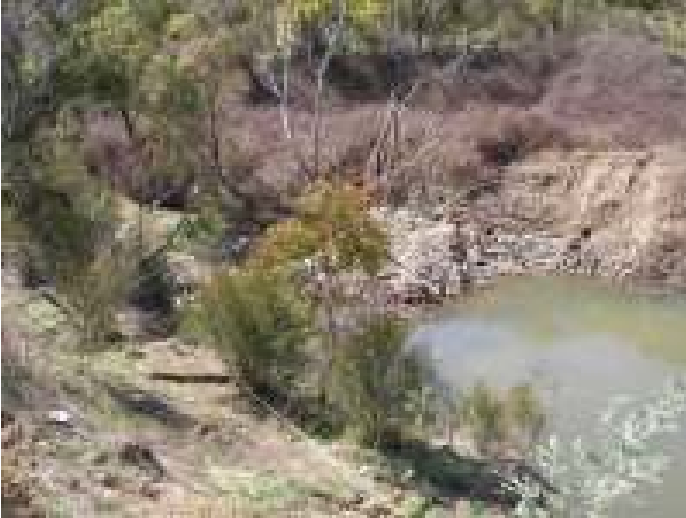
Photo log: 2006

**Description:** Rock Weir. Flow directed against the bedrock

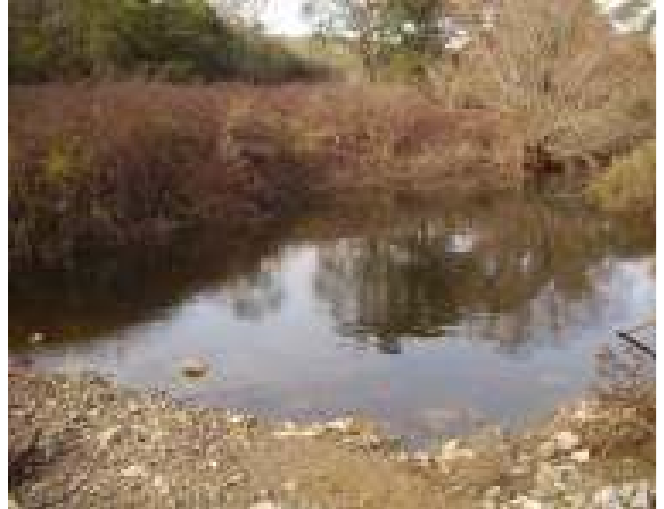
June 2008

Pond depth has increased from 0 to over 100 cm. Observations of the pond have shown that the levels have relatively stable since the installation of the leaky weir structure.

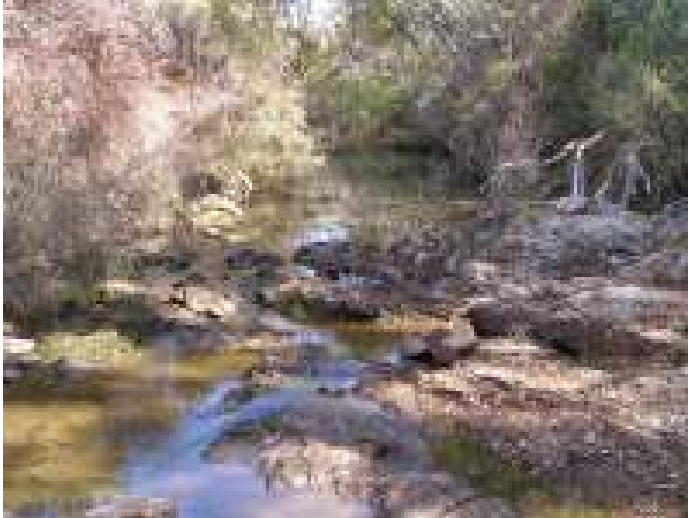
Photo log: 2006

**Description:** Bedrock controlled Pond. Automatic Flow Monitoring

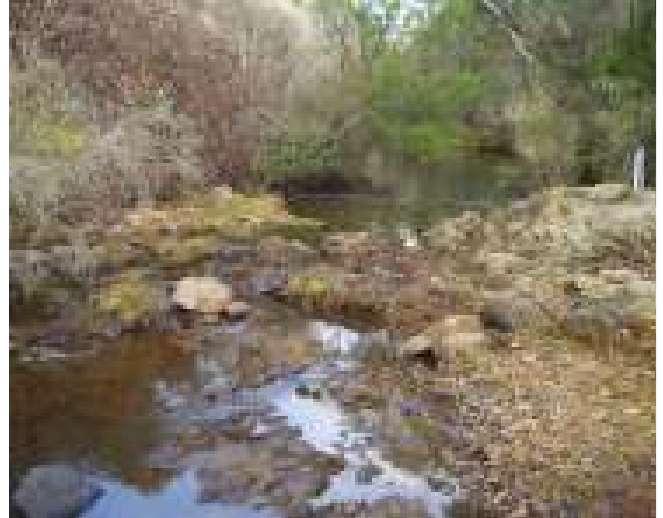
June 2008

Pond depth has increased from 2 to over 85 cm. The trend is demonstrating that this is slightly rising
